2021 PERIODIC SAFETY FACTOR ASSESSMENT REPORT

BOTTOM ASH SETTLING AREA

JEFFREY ENERGY CENTER

BLACK & VEATCH PROJECT NO. 192728

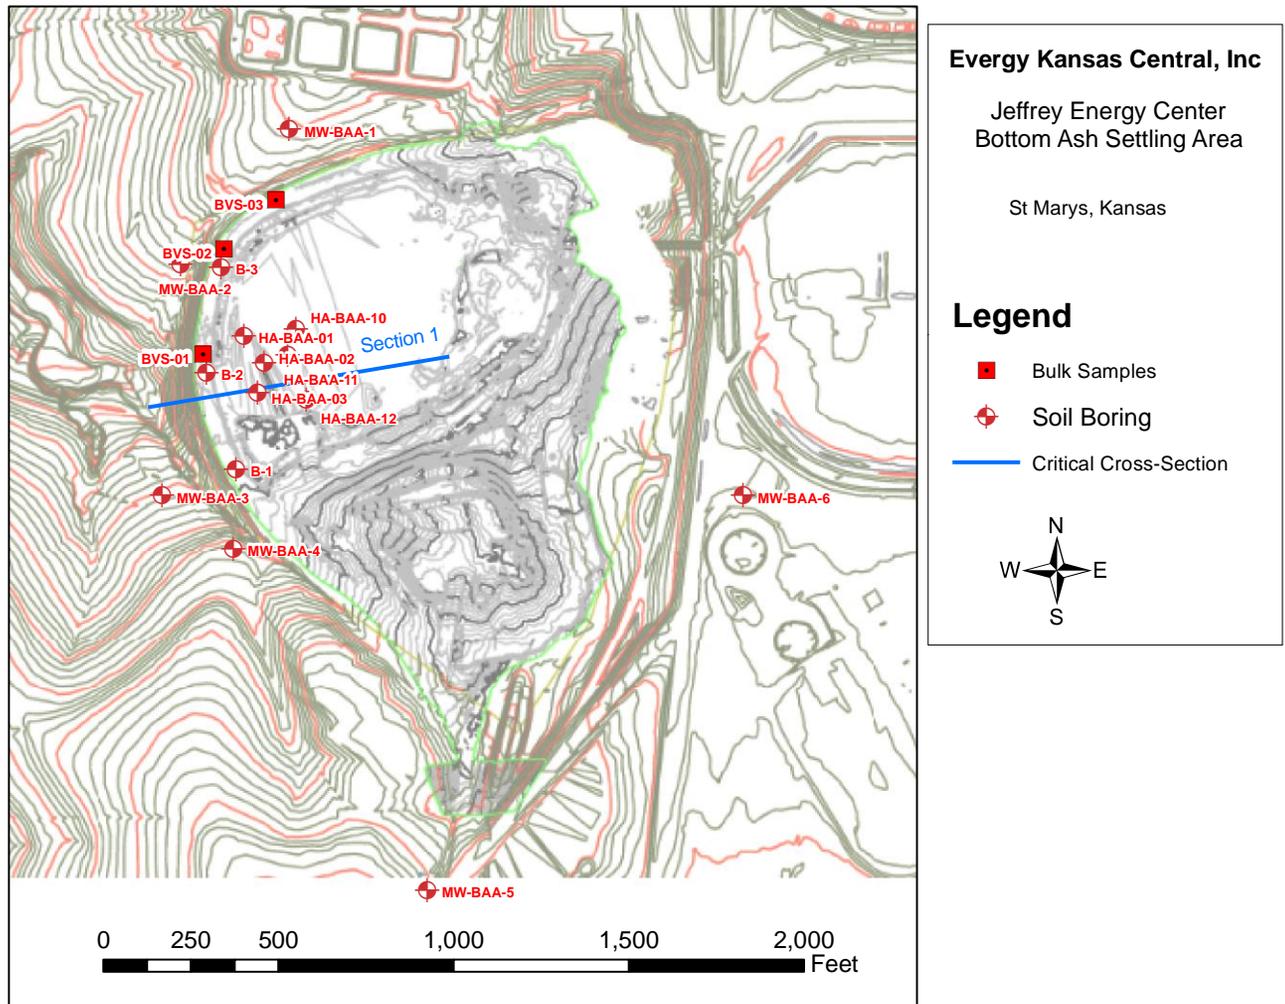
Figure 2-2 Subsurface Investigations

The geotechnical investigation included three borings along the crest of the berm (Figure 2-2). The depths of the borings varied from 31 feet to 61 feet, and each boring cored at least 10 feet into the underlying bedrock. Sampling included Standard Penetration Tests (SPT), Thin-walled samples (Shelby Tubes), bulk samples, and rock cores. Laboratory testing includes soil moisture, dry density, Atterberg limits, grain size analysis, unconfined compressive strength, and direct shear testing. A standard Proctor test was performed on the fly ash/bottom ash material that is used as berm material.

The three borings from the 2009 Black & Veatch Report were drilled along the center axis of the berm (Figure 2-2). All three borings indicated that the berm fill consisted of fly ash/bottom ash mix that classified as silty sand. The material within the berm was described as very dense, tan, brown and gray, silty, fine grained sand with a trace of gravel. Design soil properties for this layer were determined based on average values from laboratory testing and are listed in Table 3-2. Note that portions of the berm face are currently armored with a rip-rap surfacing. This material is not accounted for in the slope stability as the effect on the stability is considered negligible.

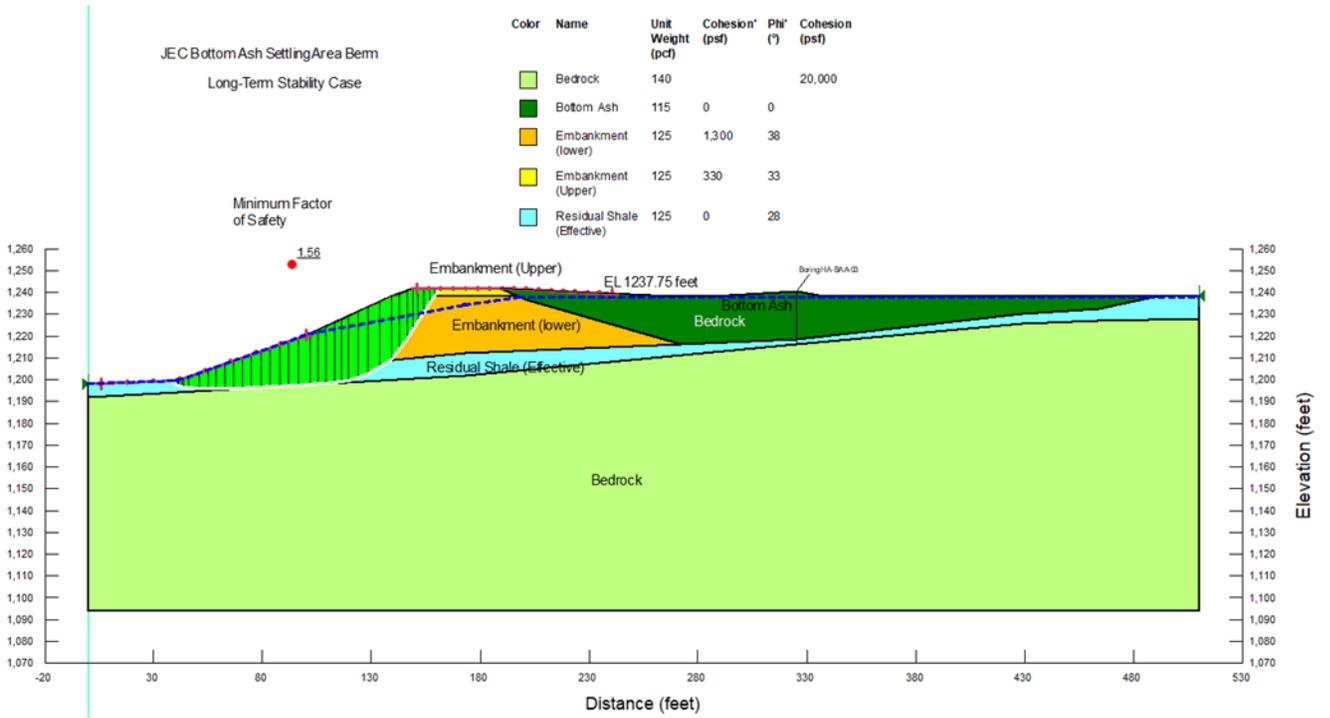
Figure 4-1 Slope Stability Results – Long-Term Stability Case

The long-term maximum storage loading condition represents the condition with the pool at normal operating condition under steady-state seepage conditions. The minimum factor of safety determined for the Long-term Maximum Storage analysis is 1.56, which is greater than the required factor of safety listed in Table 4-1 (Figure 4-1).

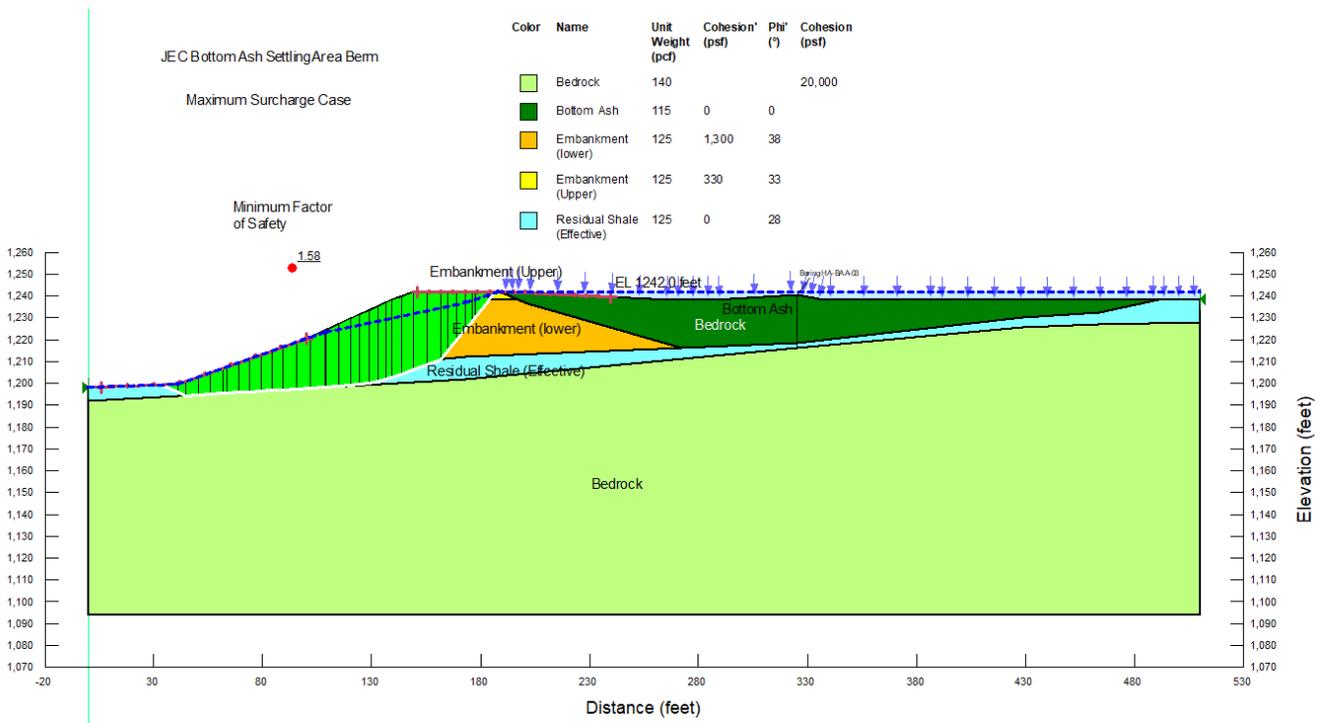
Figure 4-2 Slope Stability Results – Maximum Surcharge Case

According to the CCR Rule Preamble Part VI (E)(3)(b)(ii)(c), the maximum surcharge pool loading condition is meant to ensure that the impoundment can withstand a temporary rise in the pool elevation. The berm has an outlet invert pipe elevation of 1237.75 feet. Additionally, a culvert along the north edge of the berm allows water to exit the impoundment prior to the berm over topping. If these systems are both unserviceable, then the low elevation along the top of the berm will control the water elevation, which is 1242 feet. This water elevation will be used to compute the maximum surcharge loading. The CCR rule Preamble notes that this loading condition should consider the condition to occur long enough for steady-state seepage conditions to occur within the embankment; therefore drained, or effective stress soil properties were used for this case. The results for this case indicated a minimum factor of safety of 1.58, which is greater than the required factor of safety listed in Table 4-1 (Figure 4-2).

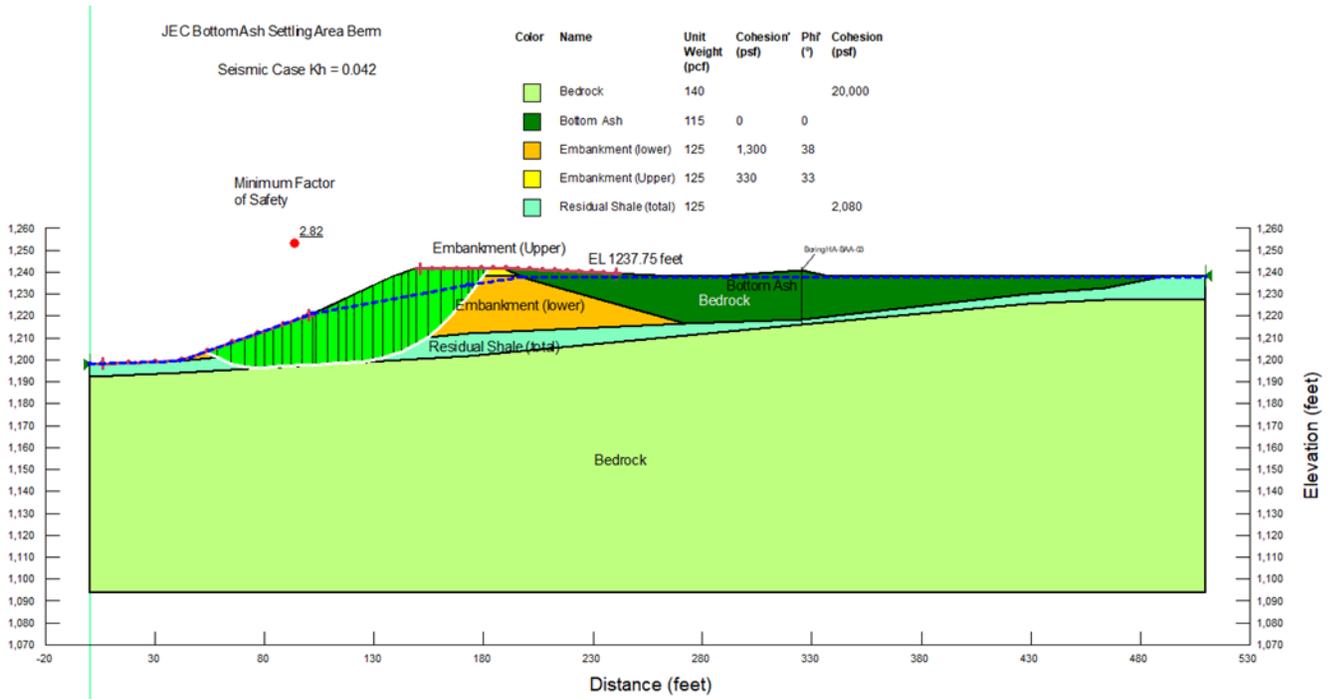
Figure 4-3 Slope Stability Results – Seismic Case

In accordance with the CCR rule, the PGA value was determined based on an earthquake event with a 2% probability of exceedance in 50 years which is equivalent to a return period of approximately 2,475 years. The earthquake conditions were determined based on the U.S. Geological Survey (USGS) National Seismic Hazard Maps which indicated PGA of 0.084 at the bedrock. A k_h value of 0.5×0.084 or 0.042 was used to simulate the horizontal earthquake loading using pseudo-static methods in the limit equilibrium slope stability analyses for the seismic loading condition. The results for this case indicated a minimum factor of safety of 2.82, which is greater than the required factor of safety listed in Table 4-1 (Figure 4-3).
