## Annual Inspection Report Tecumseh Energy Center Industrial Landfill #0322

Westar Energy

Tecumseh Energy Center

January 2017

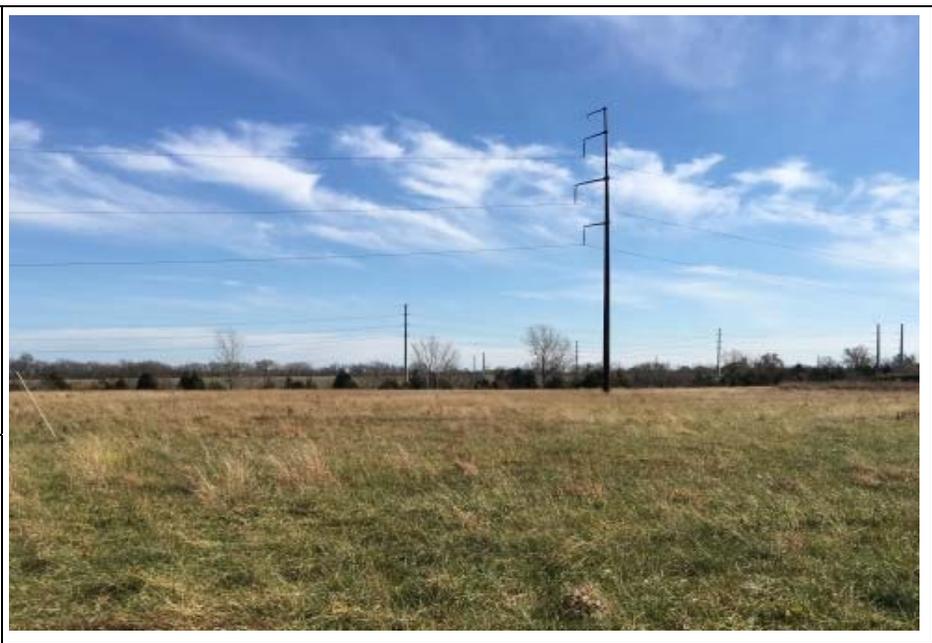
<p><b>Photograph No. 1</b></p> <p><b>Date:</b> November 28, 2016</p> <p><b>Direction:</b> Southeast</p>

<p><b>Description:</b> Observing the final cover system at Phase I. Vegetation is well-established and maintained. No evidence of sloughing or ponding.</p>

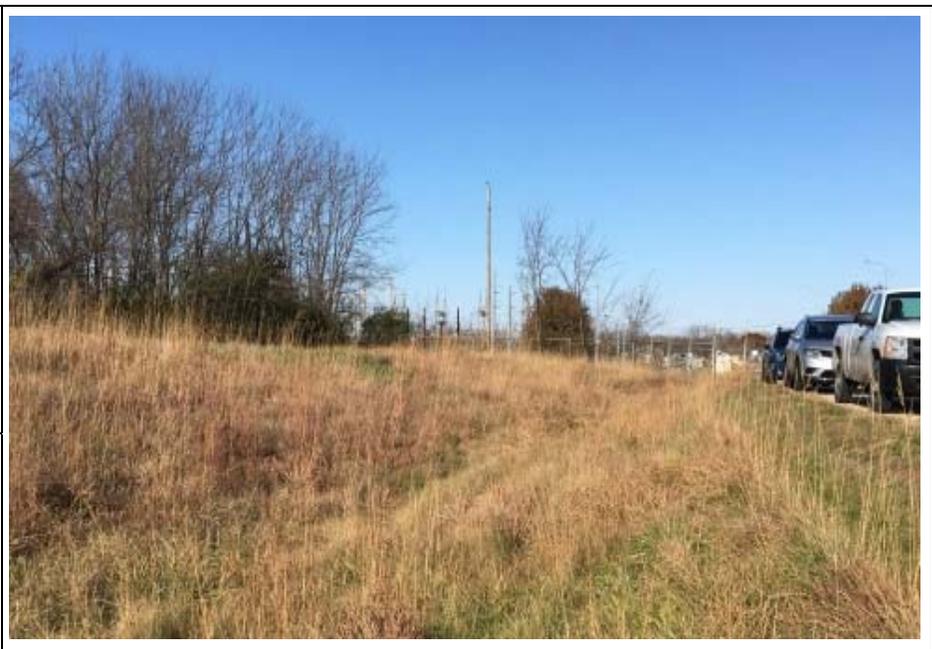
<p><b>Photograph No. 2</b></p> <p><b>Date:</b> November 28, 2016</p> <p><b>Direction:</b> North</p>

<p><b>Description:</b> Stormwater drainage ditch on west side of landfill. No evidence of obstructions or erosion.</p>

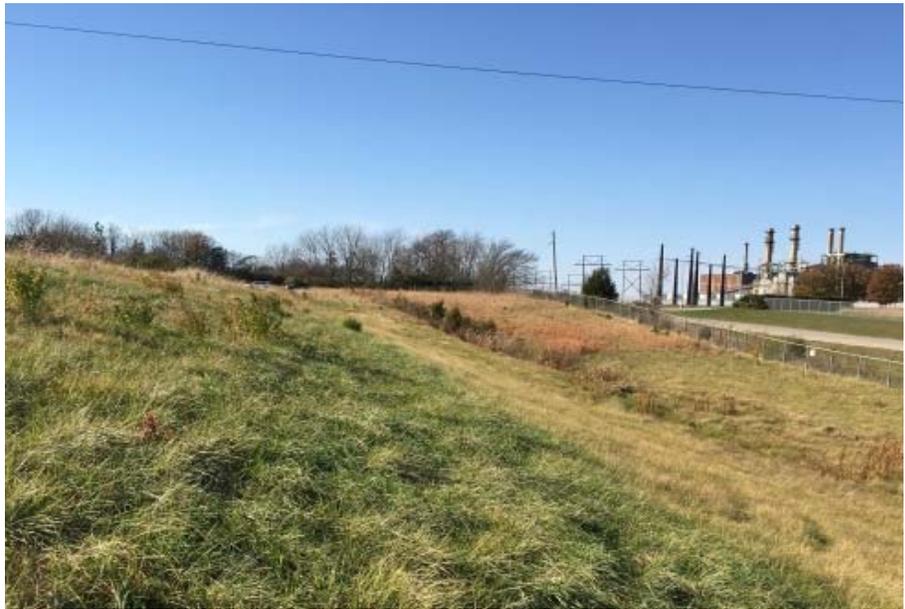
<p><b>Photograph No. 3</b></p> <p><b>Date:</b> November 28, 2016</p> <p><b>Direction:</b> West</p>

<p><b>Description:</b> North slope of Phase 1. Vegetation is well-established and maintained. No evidence of sloughing or tensile cracking.</p>

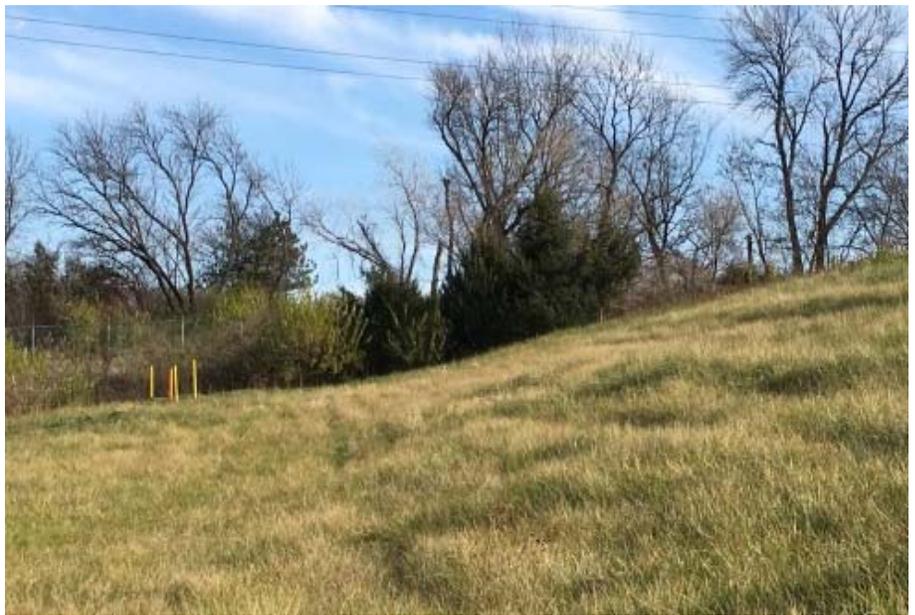
<p><b>Photograph No. 5</b></p> <p><b>Date:</b> November 28, 2016</p> <p><b>Direction:</b> East</p>

<p><b>Description:</b> North slope of Phase 1 with Monitoring Well-6 in background. Vegetation is well-established and maintained. No evidence of sloughing or tensile cracking.</p>

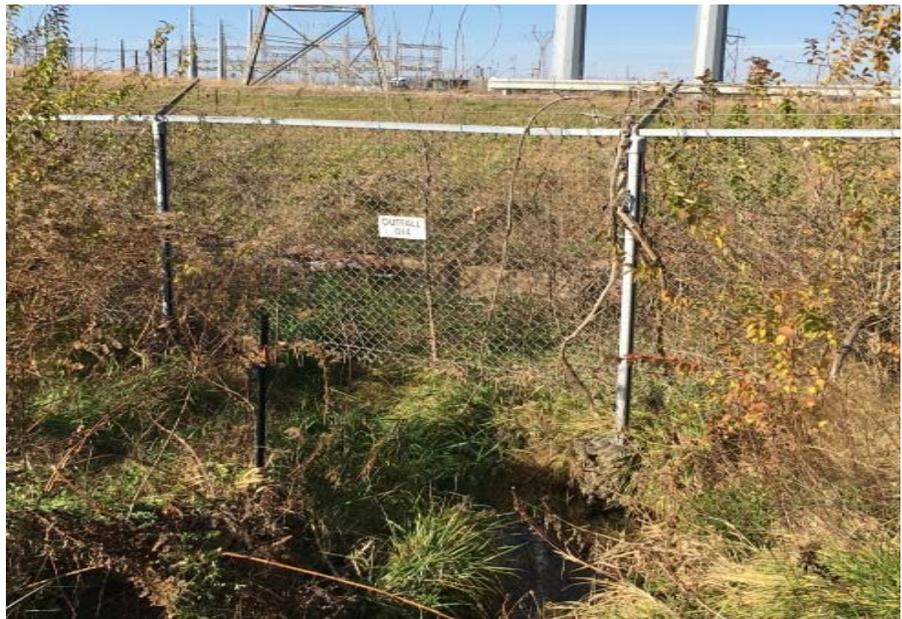
<p><b>Photograph No. 6</b></p> <p><b>Date:</b> November 28, 2016</p> <p><b>Direction:</b> North</p>

<p><b>Description:</b> Observing stormwater Outfall 014. Appeared free draining and free of obstructions.</p>

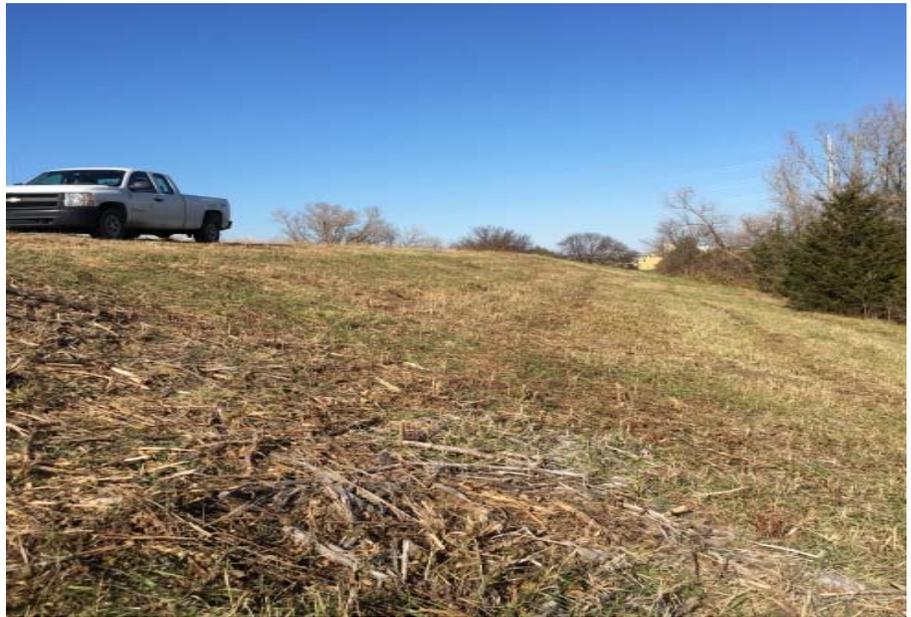
<p><b>Photograph No. 7</b></p> <p><b>Date:</b> November 28, 2016</p> <p><b>Direction:</b> North</p>

<p><b>Description:</b> East slope of Phase I. Vegetation is well-established and maintained. No evidence of sloughing or tensile cracking.</p>

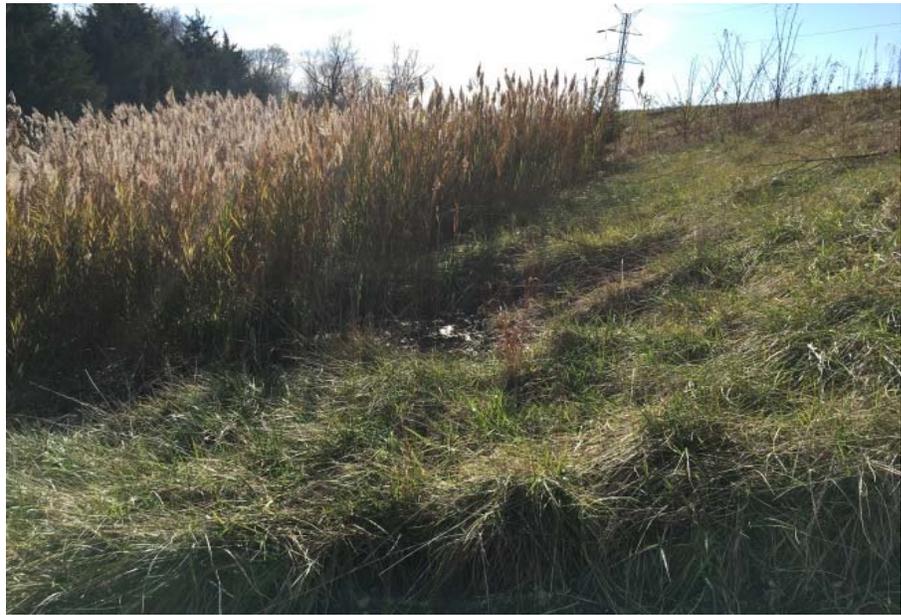
<p><b>Photograph No. 9</b></p> <p><b>Date:</b> November 28, 2016</p> <p><b>Direction:</b> South</p>

<p><b>Description:</b> Observing seep area at Phase 3. Water can be seen seeping out of side slope in general area of cattails. Remedial actions pending KDHE approval.</p>

- Implement remedial activities for seeps upon approval by KDHE.
- Continue the current maintenance procedures initiated to address seeps.
- Continue to monitor erosion controls and vegetative cover in line with the weekly inspections.
- Continue to monitor stormwater conveyance features for signs of erosion or malfunction in line with the weekly inspections

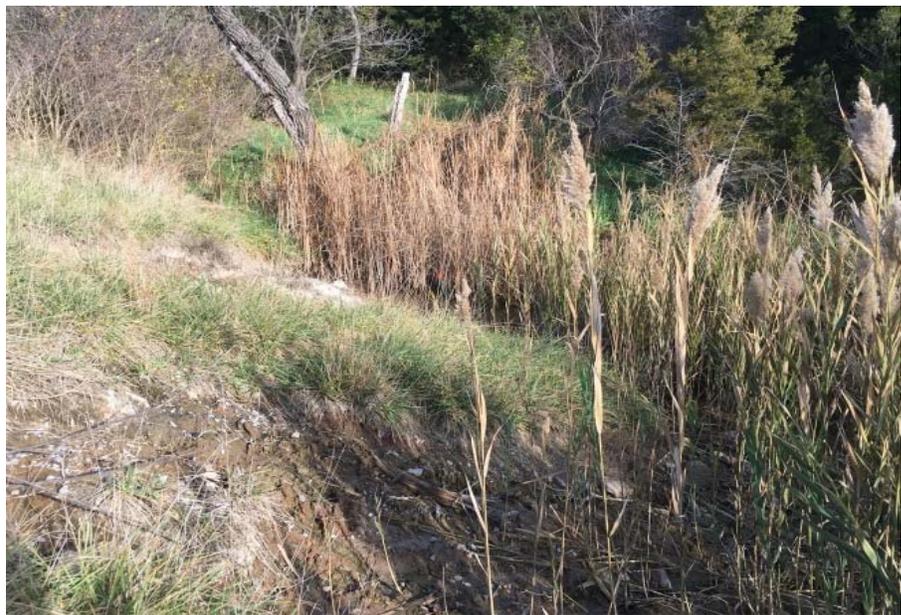
<p><b>Photograph No. 10</b></p> <p><b>Date:</b> November 28, 2016</p> <p><b>Direction:</b> North</p>

<p><b>Description:</b> Observing seep area at Phase 3. Water can be seen seeping out of side slope in general area of cattails. Evidence of gully erosion was found. Remedial actions pending KDHE approval.</p>

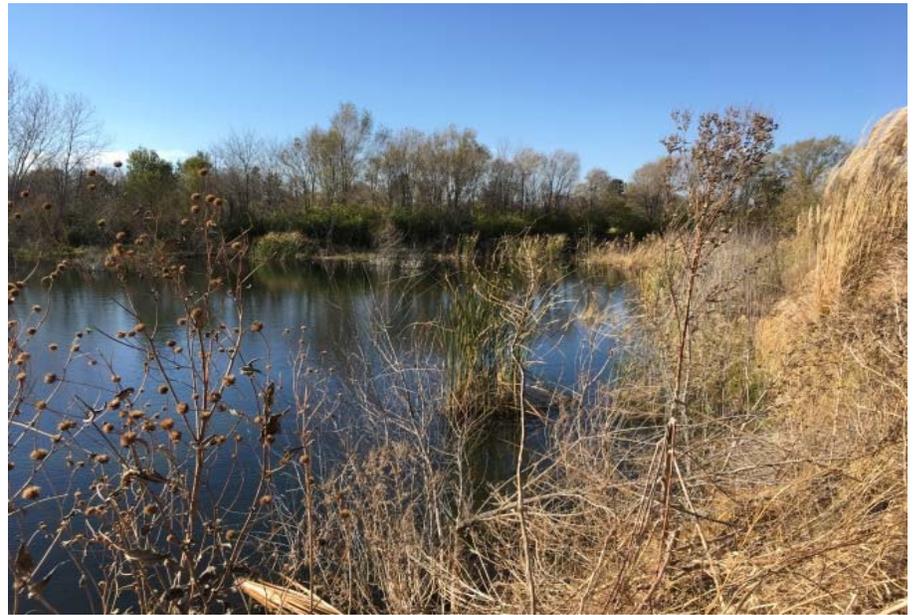
<p><b>Photograph No. 11</b></p> <p><b>Date:</b> November 28, 2016</p> <p><b>Direction:</b> West</p>

<p><b>Description:</b> Observing the Phase 3 contact water basin. No evidence of instability.</p>

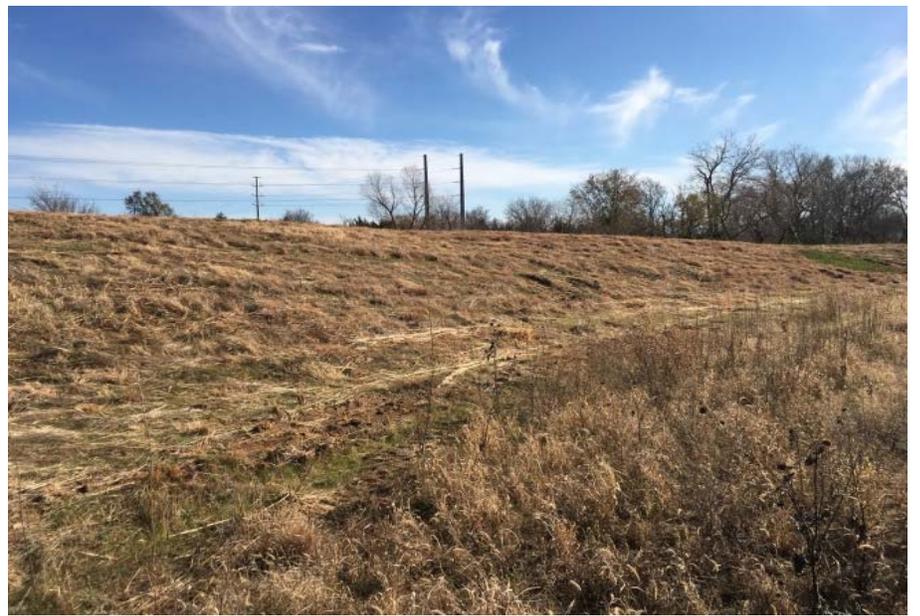
<p><b>Photograph No. 12</b></p> <p><b>Date:</b> November 28, 2016</p> <p><b>Direction:</b> Southeast</p>

<p><b>Description:</b> Observing the contact water basin perimeter berm. Vegetation is well-established and maintained. No evidence of sloughing or tensile cracking.</p>

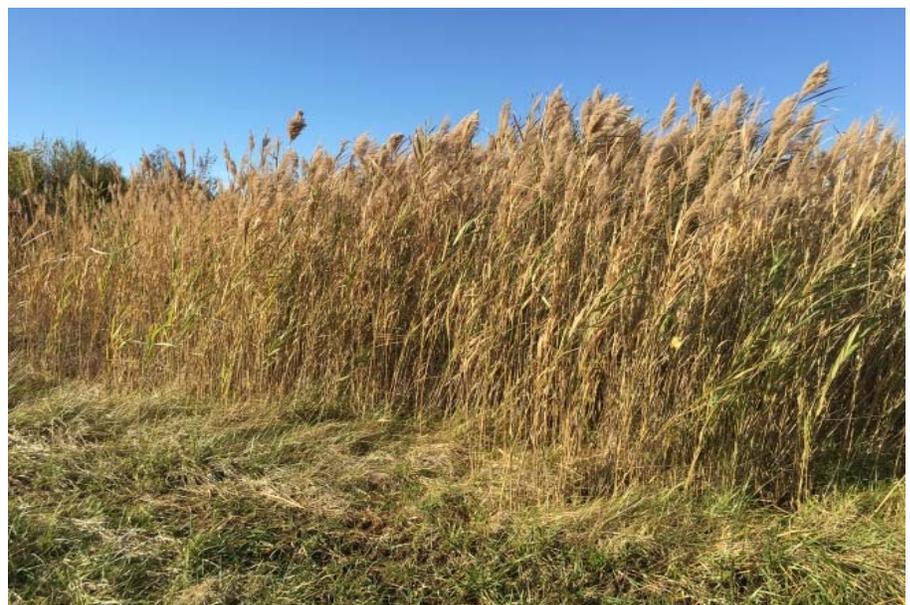
<p><b>Photograph No. 14</b></p> <p><b>Date:</b> November 28, 2016</p> <p><b>Direction:</b> Northwest</p>

<p><b>Description:</b> Observing seep area at Phase 2. Water seeping out of side slope in general area of cattails. Remedial actions pending KDHE approval.</p>

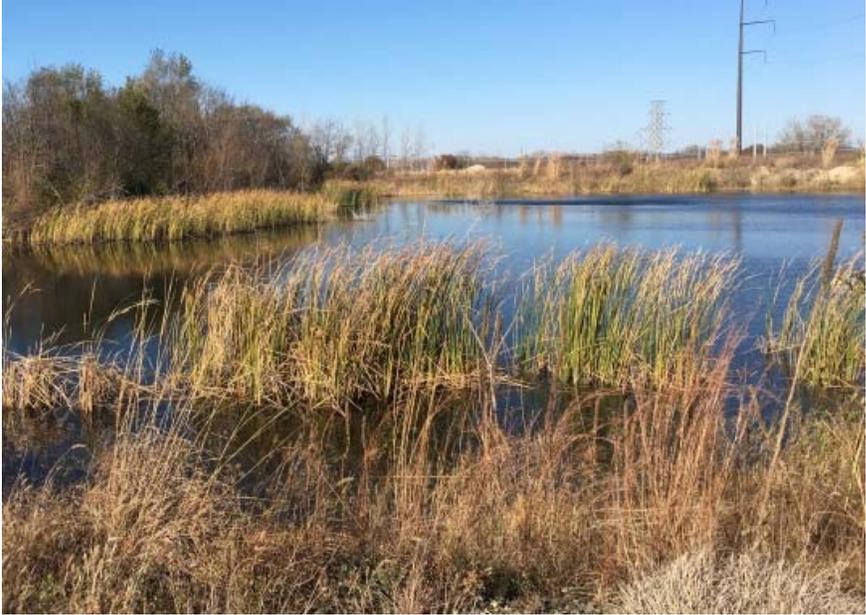
<p><b>Photograph No. 15</b></p> <p><b>Date:</b> November 28, 2016</p> <p><b>Direction:</b> North</p>

<p><b>Description:</b> Observing the Phase 3 contact water basin. No evidence of instability.</p>

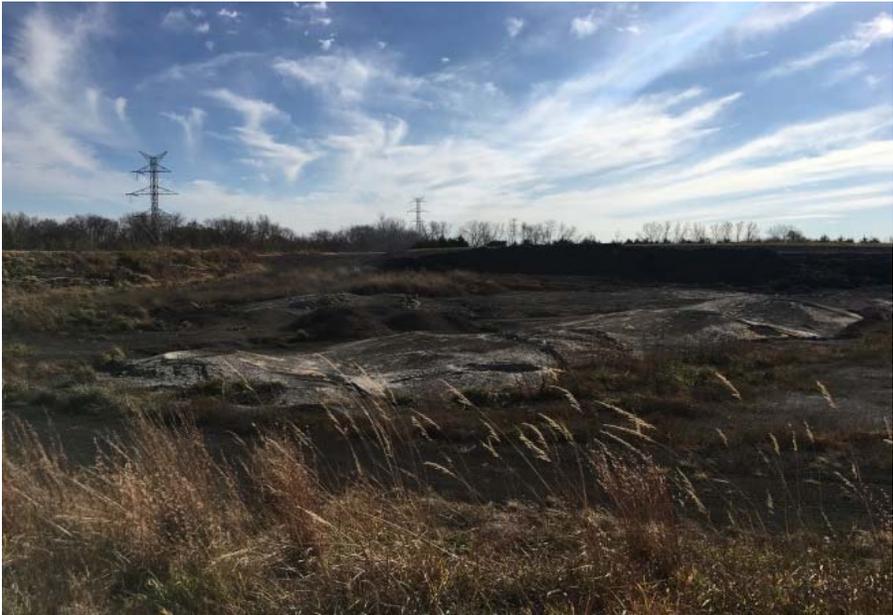
<p><b>Photograph No. 16</b></p> <p><b>Date:</b> November 28, 2016</p> <p><b>Direction:</b> South</p>

<p><b>Description:</b> Observing the active area within Phase 2. No evidence of ponding or airborne dust particles.</p>

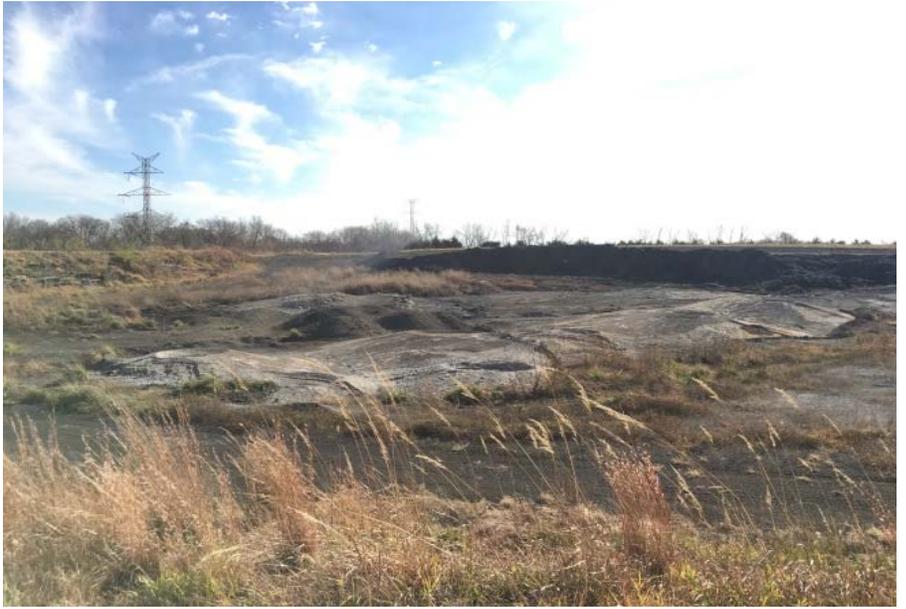
<p><b>Photograph No. 17</b></p> <p><b>Date:</b> November 28, 2016</p> <p><b>Direction:</b> West</p>

<p><b>Description:</b> Observing the active area within Phase 2. No evidence of ponding or airborne dust particles.</p>

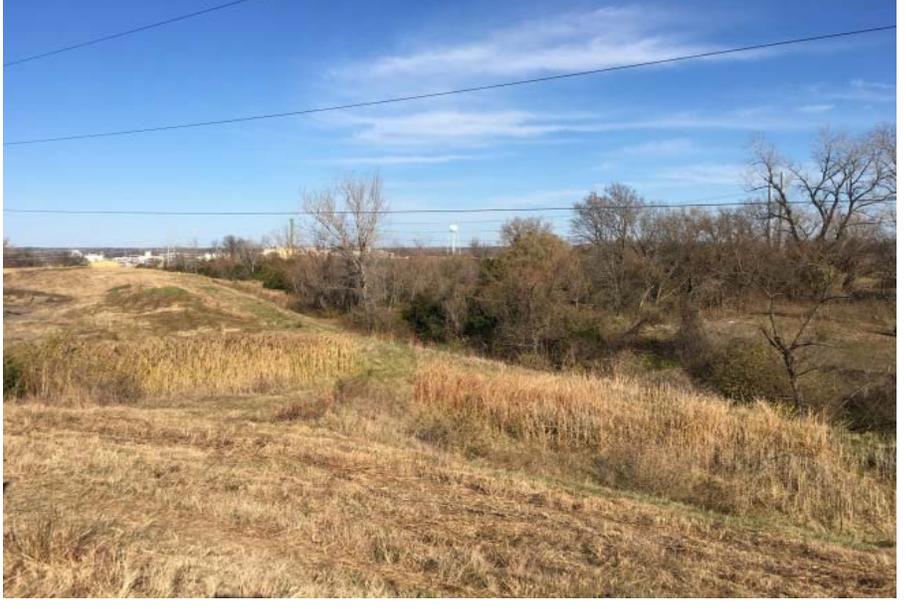
<p><b>Photograph No. 18</b></p> <p><b>Date:</b> November 28, 2016</p> <p><b>Direction:</b> Northeast</p>

<p><b>Description:</b> Observing the seep at Phase 2 seep from top of landfill berm. Eastern drainage channel is also shown.</p>

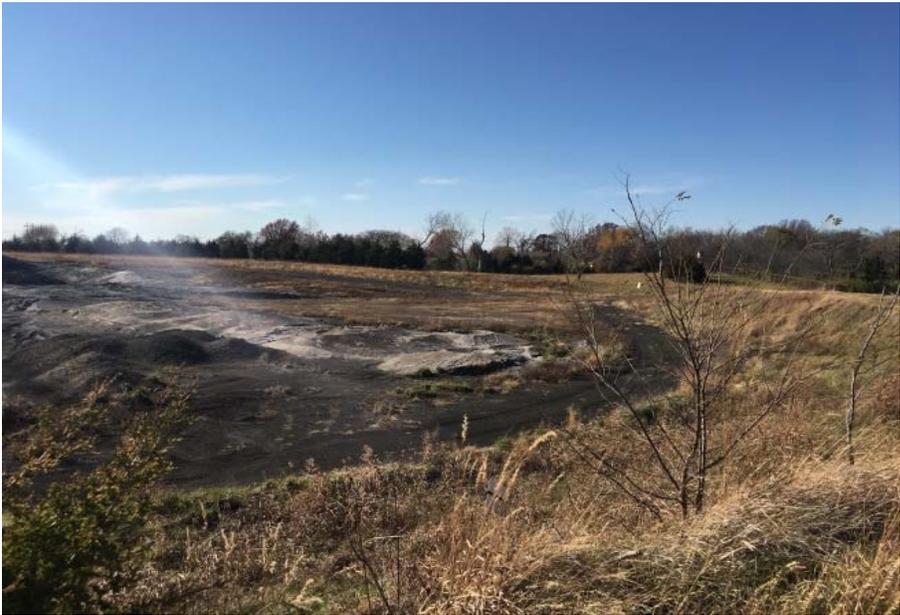
<p><b>Photograph No. 19</b></p> <p><b>Date:</b> November 28, 2016</p> <p><b>Direction:</b> Northwest</p>

<p><b>Description:</b> Observing the active area within Phase 2. No evidence of ponding or airborne dust particles.</p>

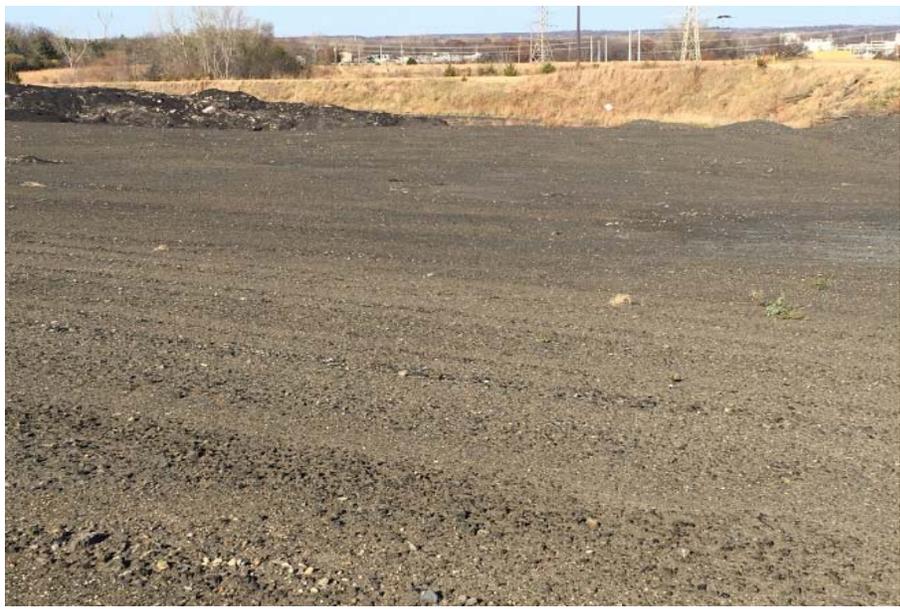
<p><b>Photograph No. 20</b></p> <p><b>Date:</b> November 28, 2016</p> <p><b>Direction:</b> North</p>

<p><b>Description:</b> Observing the smooth grading and compaction at the active area within Phase 2. No evidence of ponding or airborne dust particles.</p>

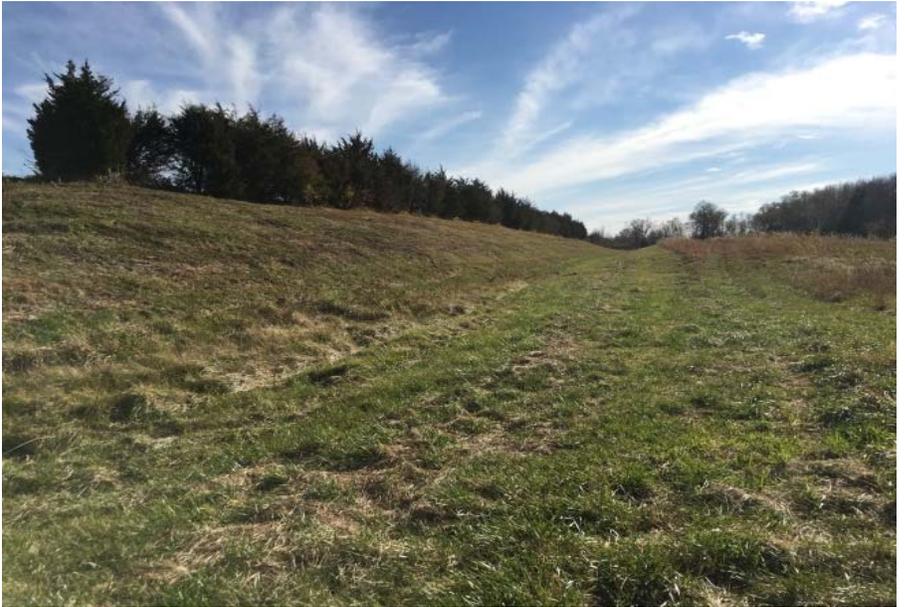
<p><b>Photograph No. 21</b></p> <p><b>Date:</b> November 28, 2016</p> <p><b>Direction:</b> South</p>

<p><b>Description:</b> Observing the west slope and perimeter drainage channel of Phase 2. Appeared free draining and free of obstructions. Vegetation is well-established and maintained.</p>

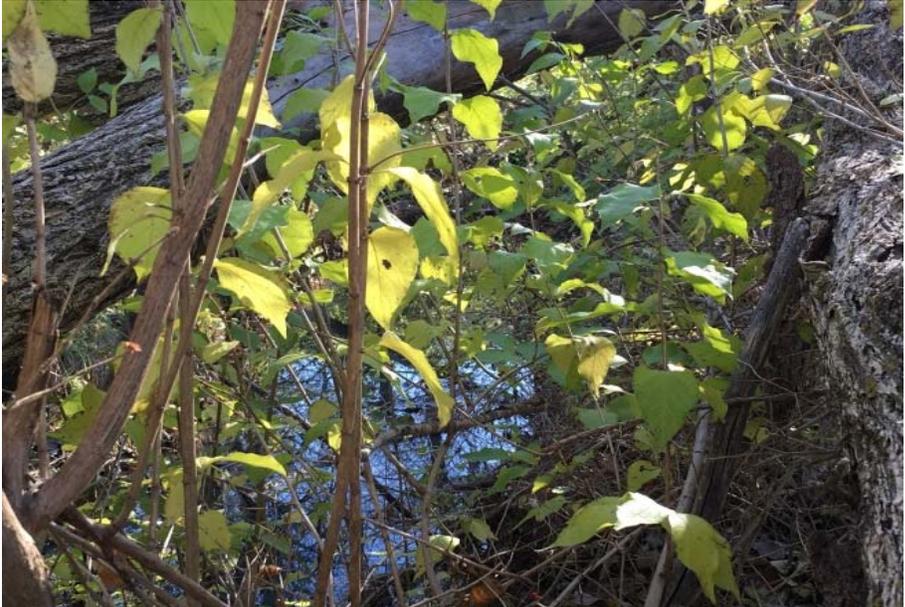
<p><b>Photograph No. 22</b></p> <p><b>Date:</b> November 28, 2016</p> <p><b>Direction:</b> East</p>

<p><b>Description:</b> Observing local creek entering the landfill property. Nominal flow.</p>

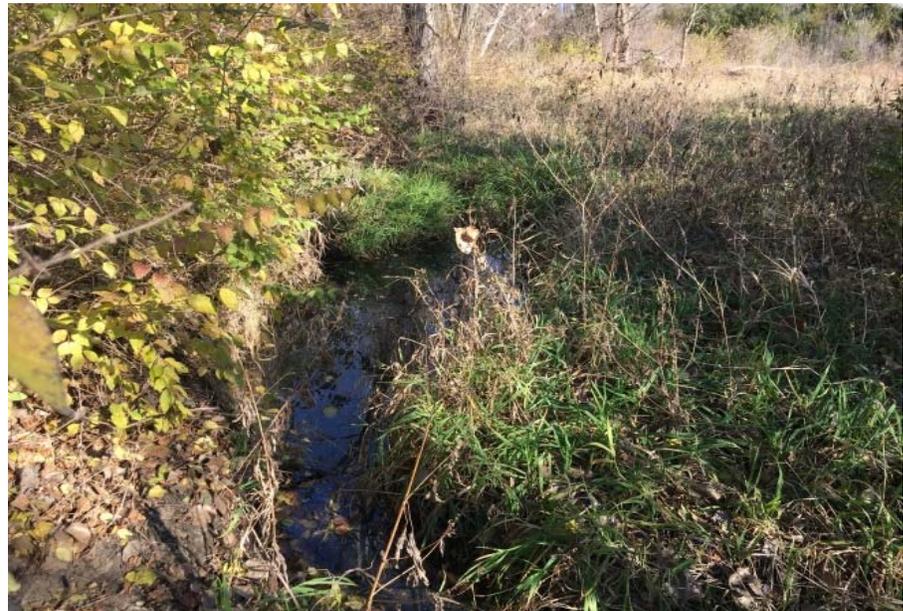
<p><b>Photograph No. 23</b></p> <p><b>Date:</b> November 28, 2016</p> <p><b>Direction:</b> East</p>

<p><b>Description:</b> Observing local creek entering the landfill property. Very nominal flow.</p>
