Annual Inspection Report Tecumseh Energy Center Bottom Ash Surface Impoundments

Westar Energy

Tecumseh Energy Center

January 2018

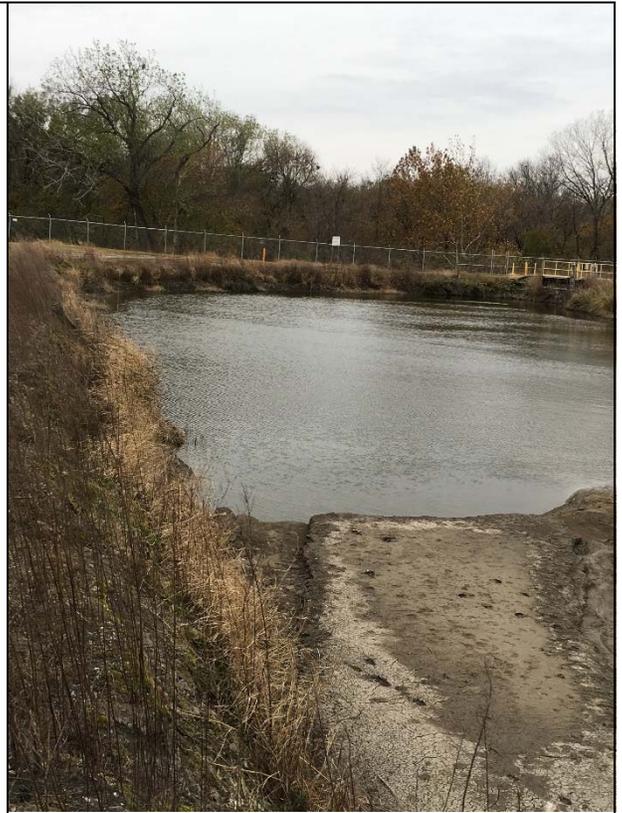
Photograph No. 1

Overview of South Pond looking toward open water area on the west side of the pond. The South Pond was not currently receiving process water at the time of Annual Inspection; process water was being directed to the North Pond. The eastern 1/2 of the pond is filled with CCR material. This material will be removed as part of routine site maintenance activities. The interior sideslopes are stable with safety or structural concerns evident.

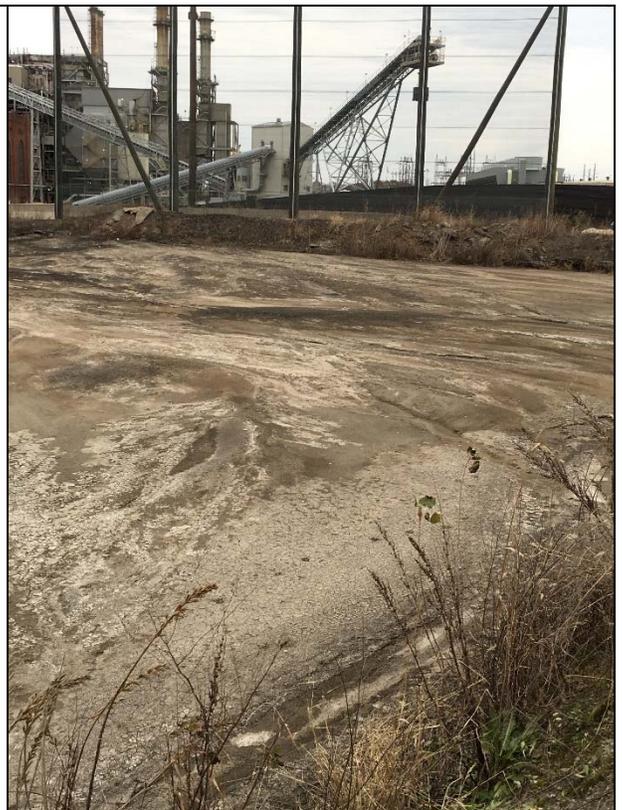
Photograph No. 2

Overview of the east side of the pond, where CCR material has accumulated. This material will be removed as part of routine site maintenance activities.

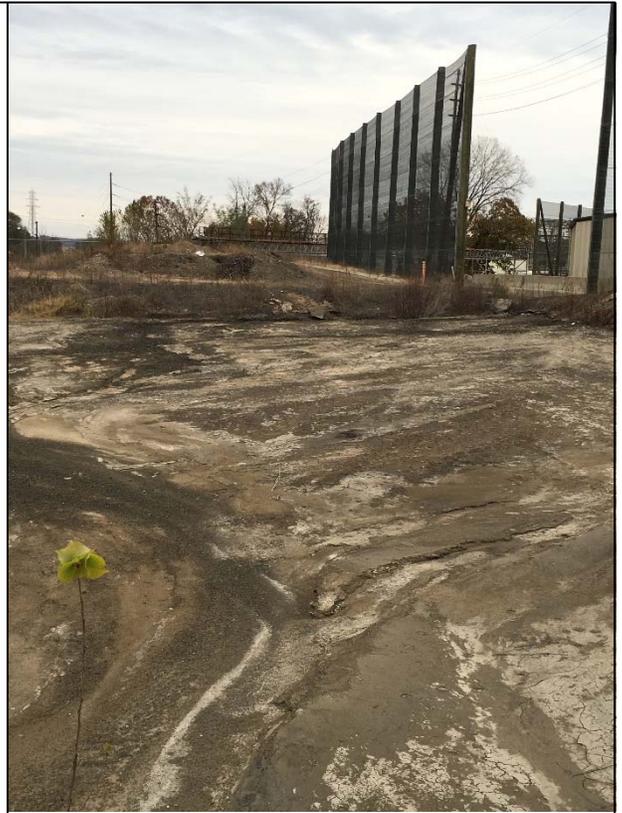
Photograph No. 3

Overview of eastern ½ of the South Pond looking toward the location where process water enters the pond when operating. Minor erosion rills shown in photo are within the settled CCR material that is contained within the impoundment, and therefore do not pose stability concerns. This CCR material will be removed as part of routine site operations.

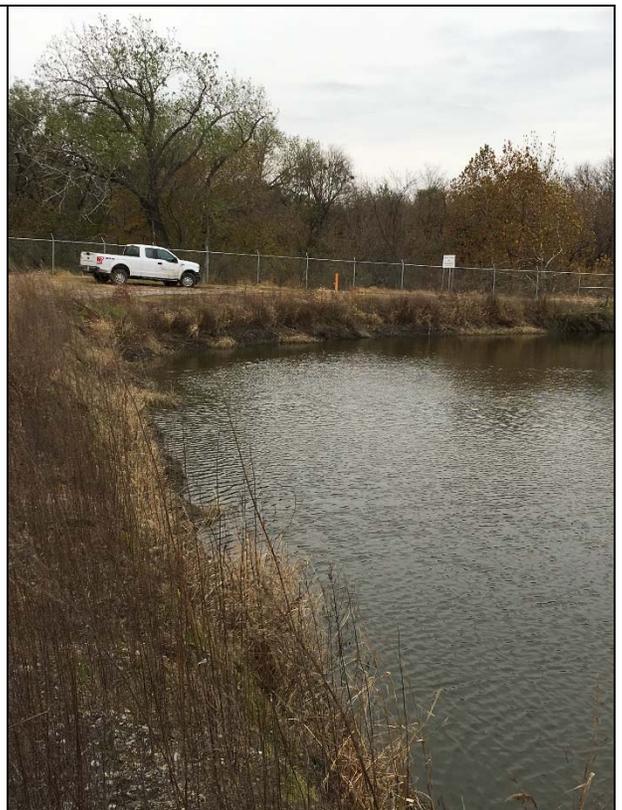
Photograph No. 4

Open water area of the South Pond, located on the western side. The interior slopes of the impoundment are shown with healthy vegetation. No stability concerns were observed.

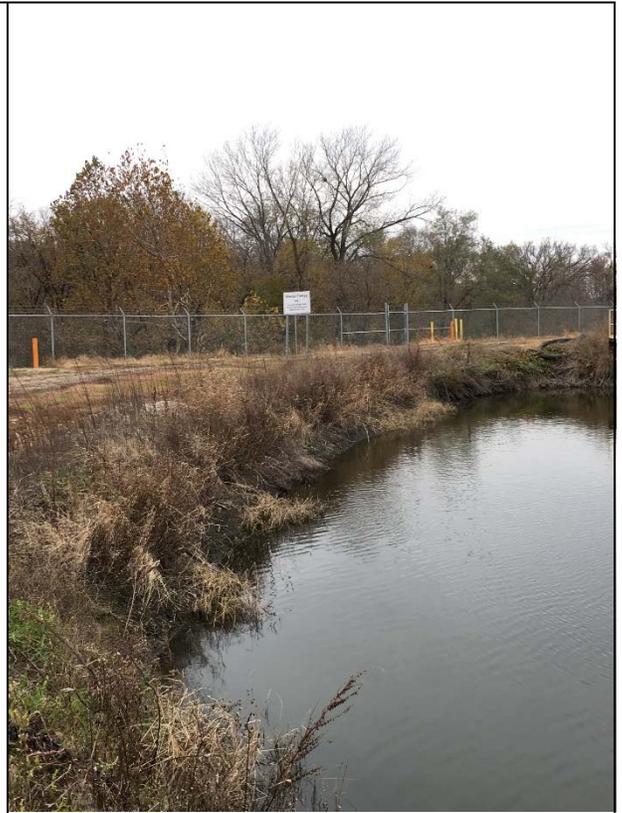
Photograph No. 5

Open water area of the South Pond, located on the western side. The interior slopes of the impoundment are shown with healthy vegetation. No stability concerns are observed.

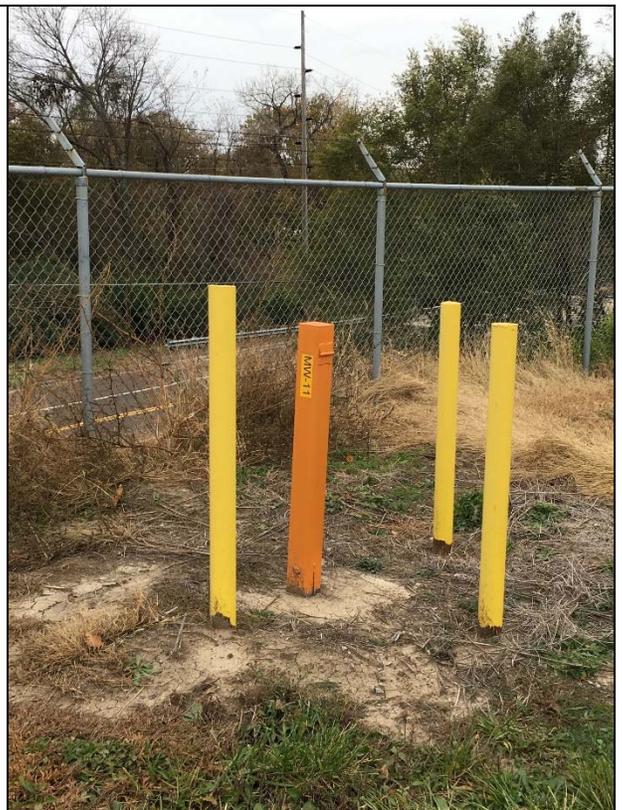
Photograph No. 6

Monitoring well MW-11, located at the southeast corner of the impoundment.

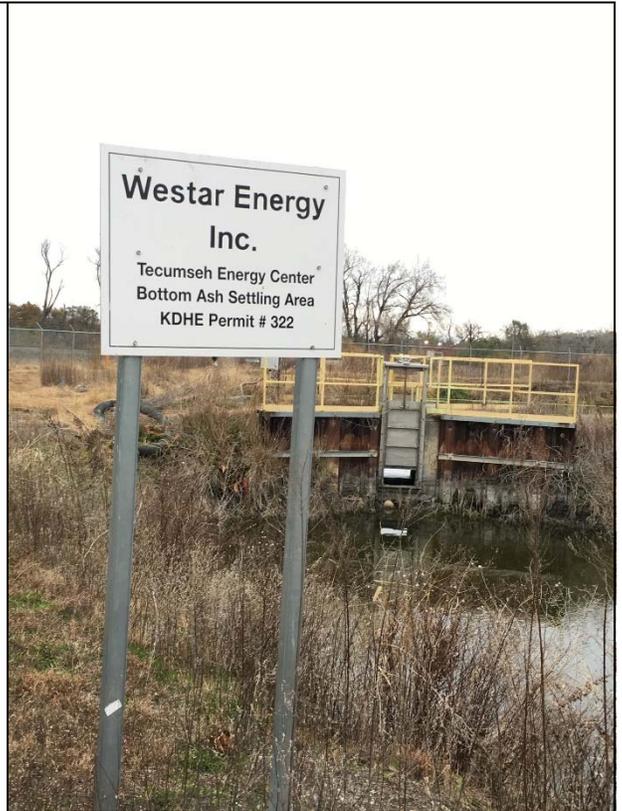
Photograph No. 7

Sign showing the name of the Impoundment. A sluice gate is shown in the background. This sluice gate allows water to be directed from either the North or South Ponds to a common pipe that serves as both ponds' outlet.

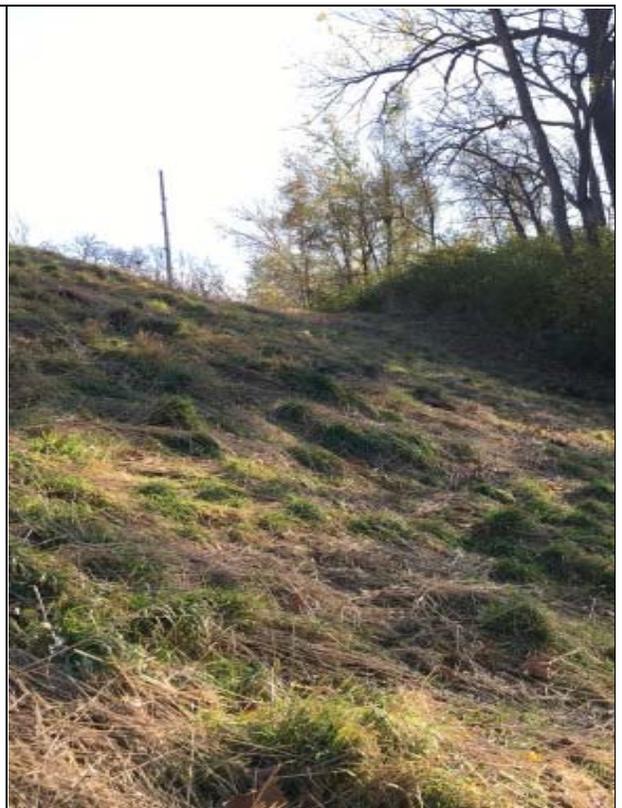
Photograph No. 8

Observing the outer west slope. Vegetation is well established. No evidence of erosion or slope stability concerns despite steep slopes.

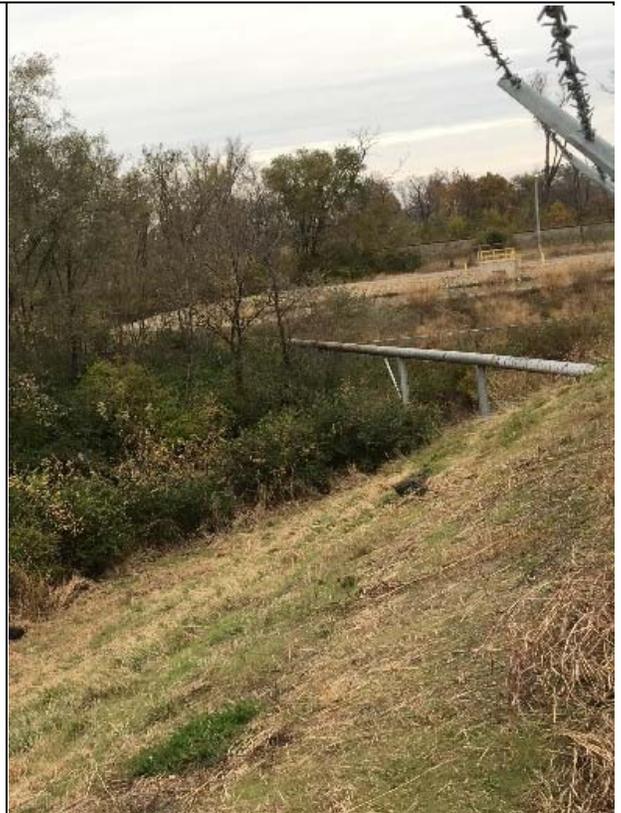
Photograph No. 9

Observing the outer west slope. Vegetation is well established and maintained. No evidence of slope stability concerns or erosion despite steep slopes.

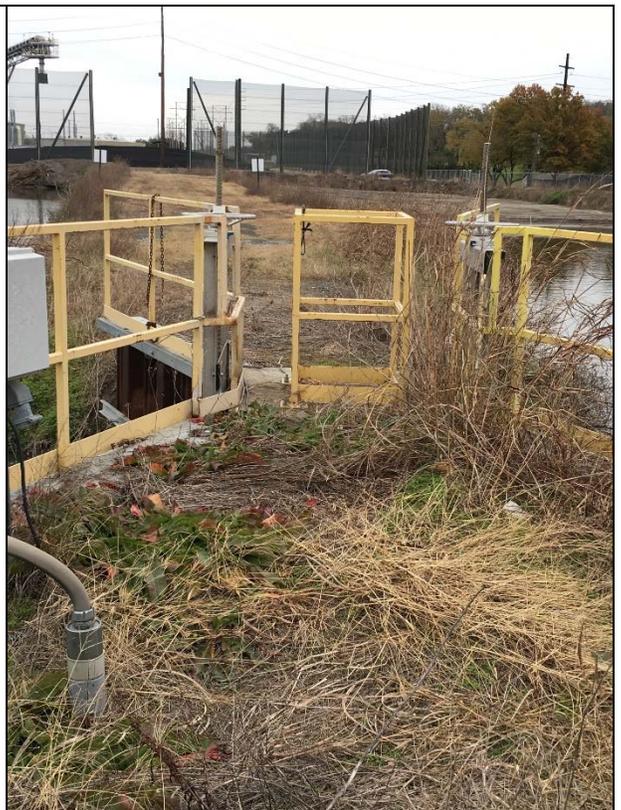
Photograph No. 10

Observing the sluice gate system between the North and South Ponds. Structure is clear of obstructions and operating appropriately.

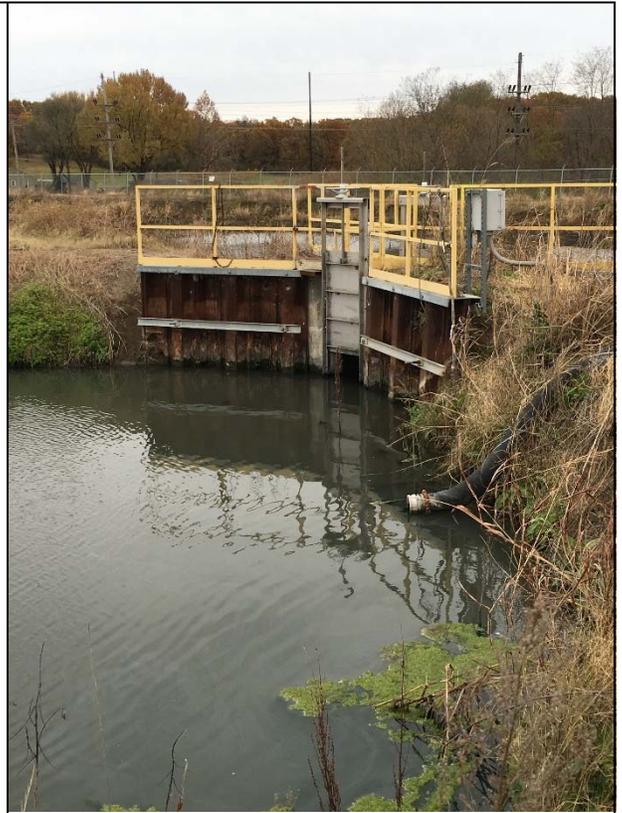
Photograph No. 11

Observing the sluice gate system between the North and South Ponds from the north. Structure is clear of obstructions and free-flowing.

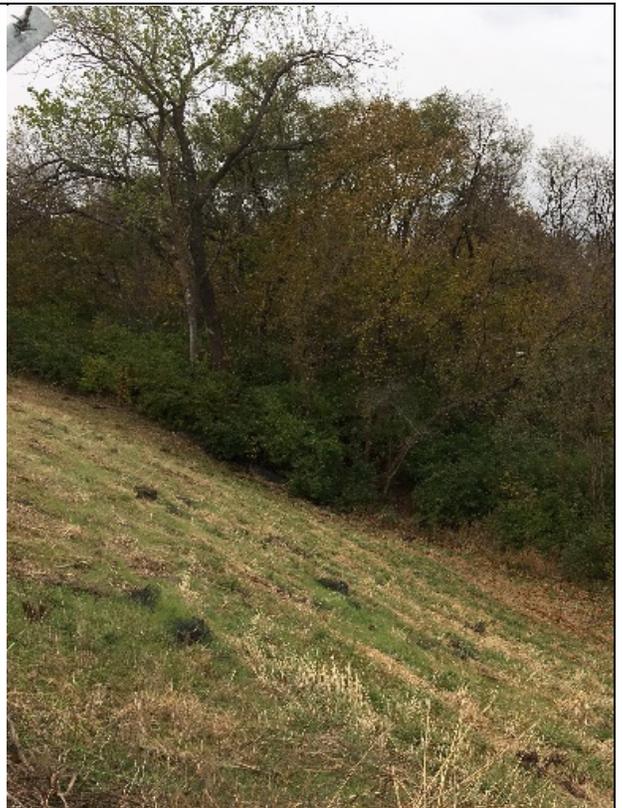
Photograph No. 12

Observing the outer west slope. Vegetation is well established and maintained. No evidence of slope stability concerns or erosion despite steep slopes.

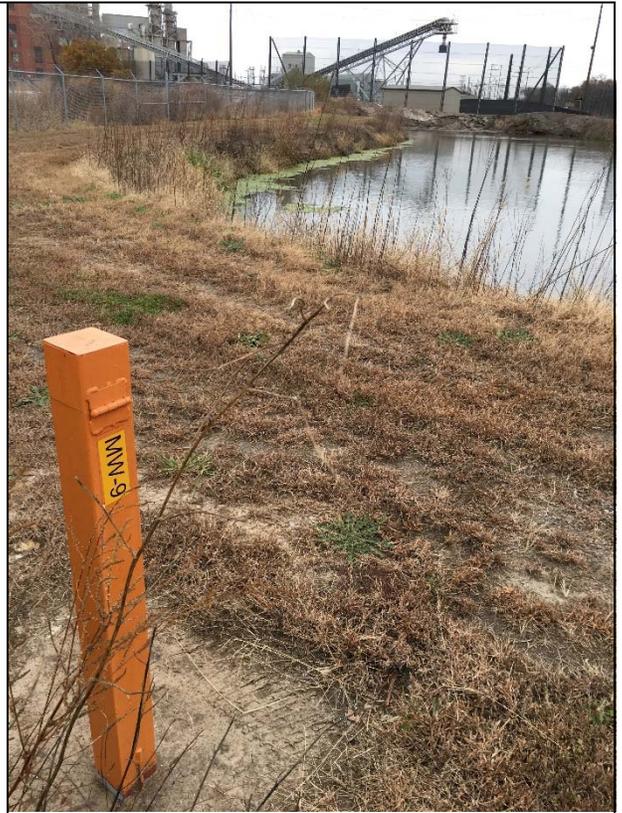
Photograph No. 13

On July 1, 2017, the North Pond of the Tecumseh Energy Center (TEC) Area 1 Surface Impoundment overtopped its western bank and released water into Tecumseh Creek. The incident was caused by the operational error of not opening a sluice gate while water was being pumped into the North Pond. Upon observation, the gate was opened to allow the controlled release of water into the normally receiving clarifying basin (the “Clear Pond”). No erosion or structural damage occurred during or after the overtopping event. While the total volume of water that overtopped the impoundment is known, it is estimated that the quantity of water released is minimal based on a review of inflow rates and freeboard.

Ground area near MW-9. This was the general location of an overtopping incident that occurred in 2017 due to the sluice gate being closed, thereby removing access to the outlet pipe. There is no evidence of erosion, damage to vegetation, soil migration, or stability issues in this area. There is no visual evidence of the overtopping incident.

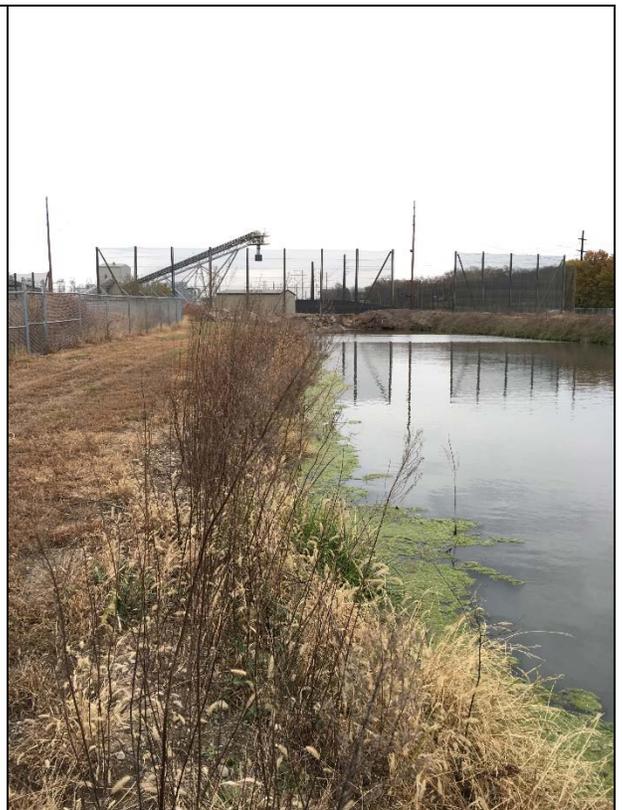
Photograph No. 14

Observing the north interior slopes of the North Pond. Vegetation is healthy. No evidence of stability concerns.

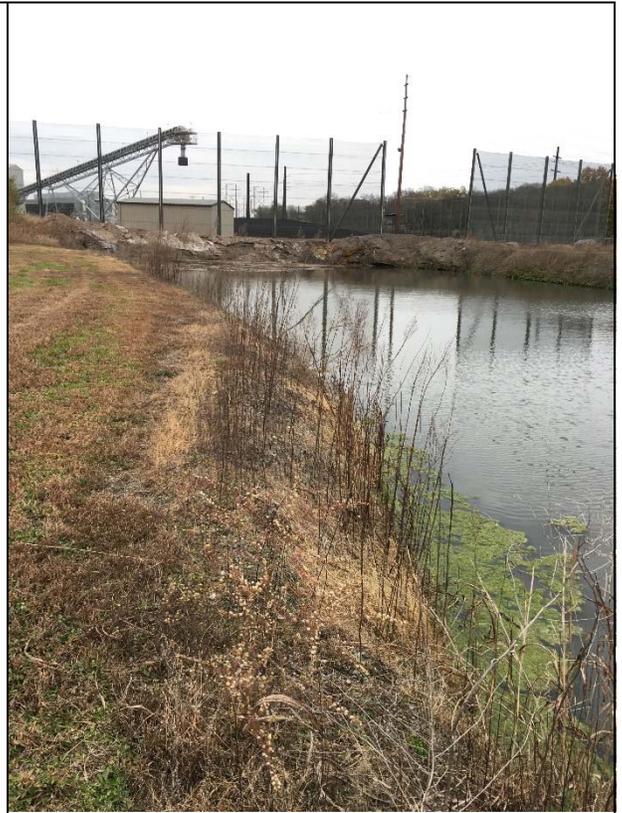
Photograph No. 15

Observing the north interior slopes of the North Pond. Vegetation is healthy. No evidence of stability concerns.

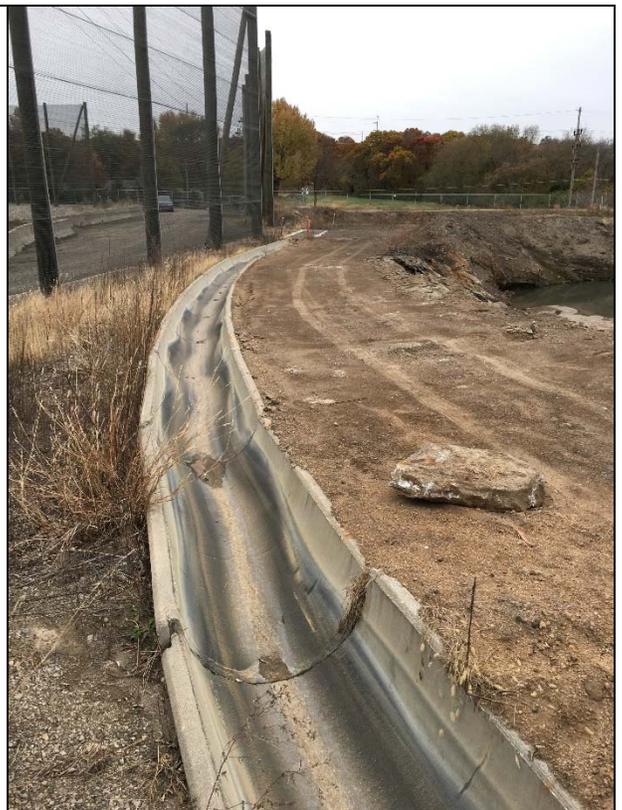
Photograph No. 16

Flume that directs process water to South Pond. The flume is free of obstructions and well maintained.

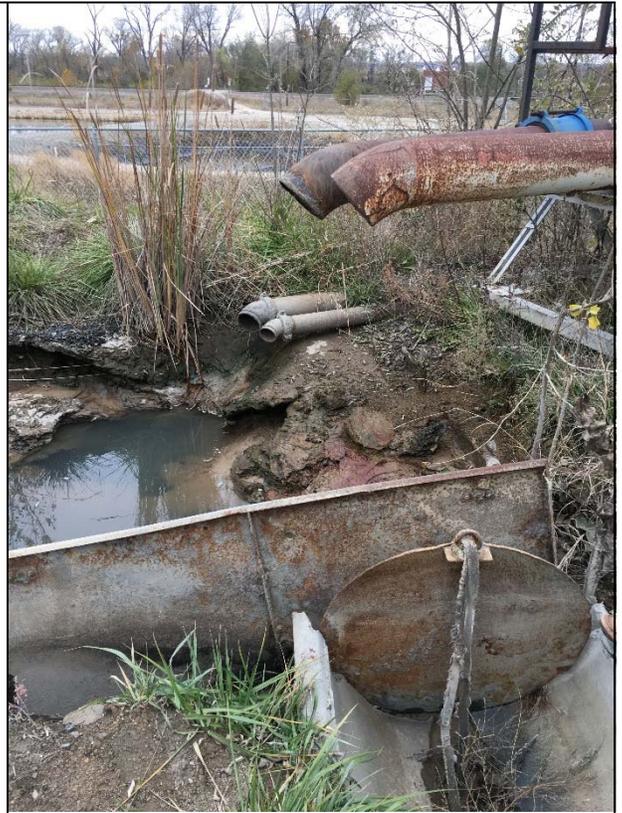
Photograph No. 17

Process water entry point into pond system. Process water enters from the large pipes into a central plunge pool. Water is then directed to either the North or South Pond by opening the appropriate gate. Process water was being directed to the North Pond at the time of inspection. The system was functioning as intended.

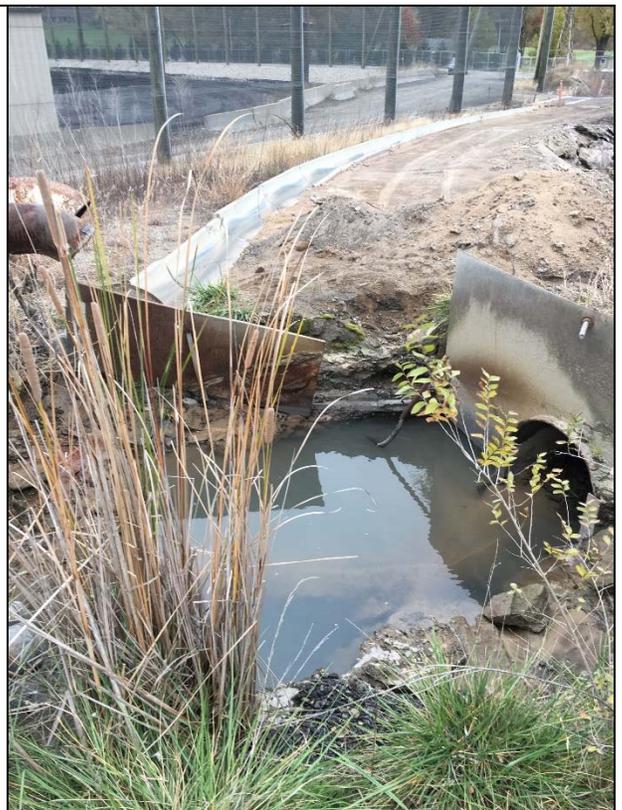
Photograph No. 18

Plunge pool of Photograph 17 looking at the pond entry points. The pipe on the right side of the photograph allows water to enter the North Pond. The flume in the upper portion of the photograph conveys water to the South Pond when operating. The flume currently has a gate preventing entry of process water, while the North Pond inlet is open.

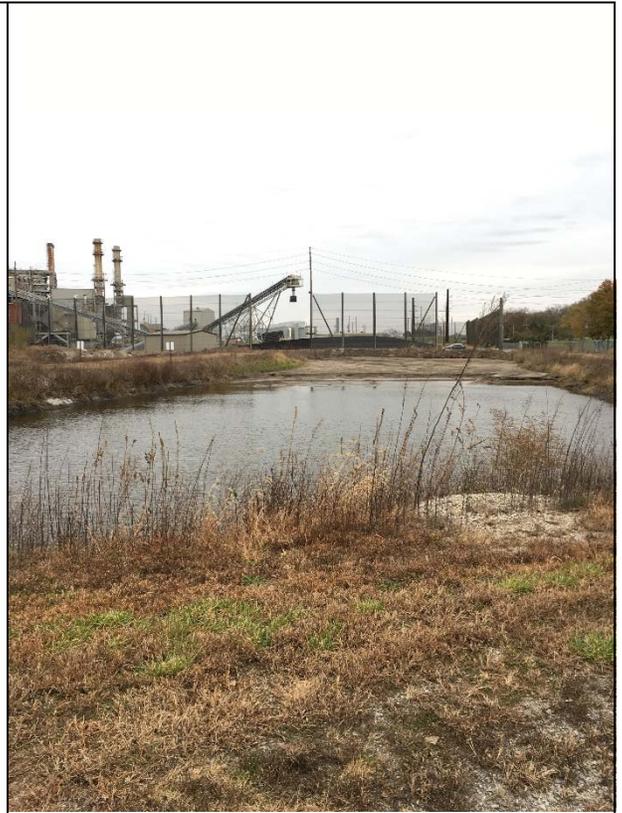
Photograph No. 19

Observing the North Pond interior. In good condition and functioning as intended.

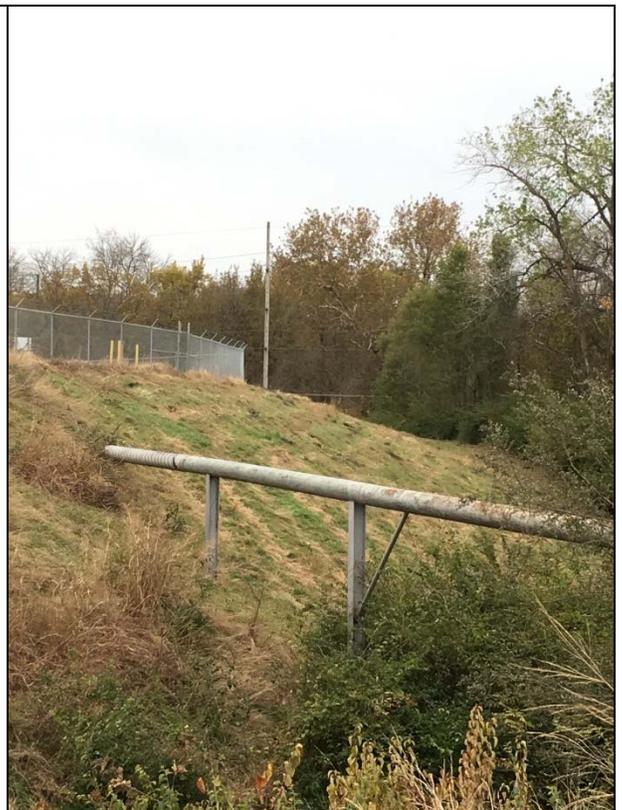
Photograph No. 20

Observing the outer west slope. Vegetation is well established and maintained. No evidence of slope stability concerns or erosion.

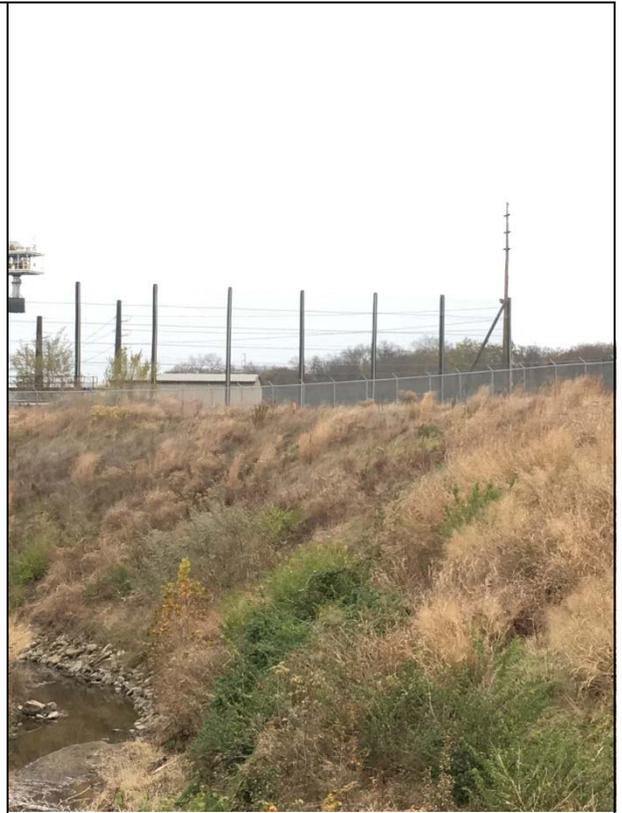
Observing the outer north slope. Vegetation is well established and maintained. No evidence of slope stability concerns or erosion despite steep slopes.

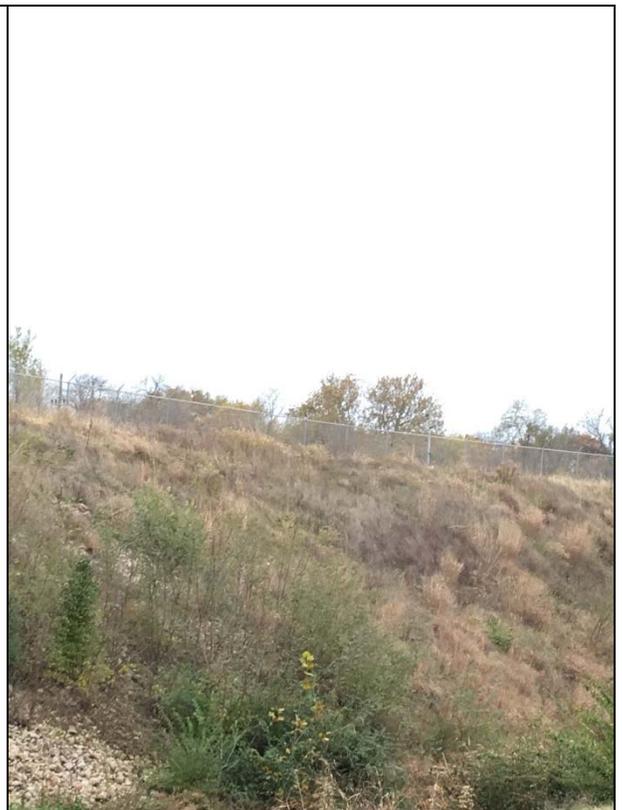
Photograph No. 22

Observing the outer north slope. Vegetation is well established and maintained. No evidence of slope stability concerns or erosion.

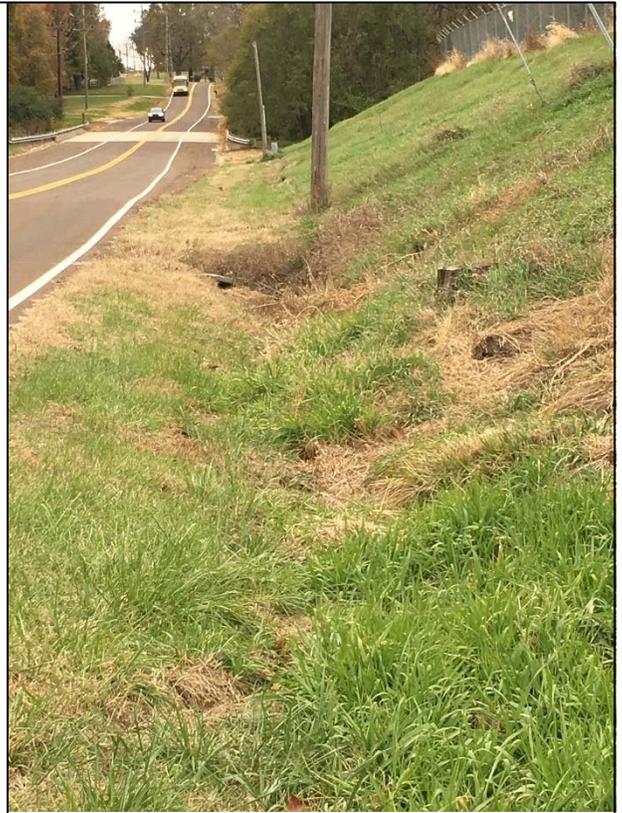
- ❑ Erosion and incising within the drainage ditch along SE 2nd Street at the base of the southern perimeter berm.
- ❑ Minor erosion on the inside slopes of the Surface Impoundments.

South berm of South Pond along SE 2nth St. Channelizing of perimeter ditch that were observed during previous Annual Inspection have been corrected through regrading. Vegetation is established and well maintained. Drainage channel at the toe of the slope is now functioning as intended.

- Inspection for animal burrows is completed throughout the year, which are promptly filled upon identification.
- Vegetation on slopes have been cut and maintained to an appropriate height.
- Regrading of the SE 2nd Street drainage ditch has been completed to address incising.

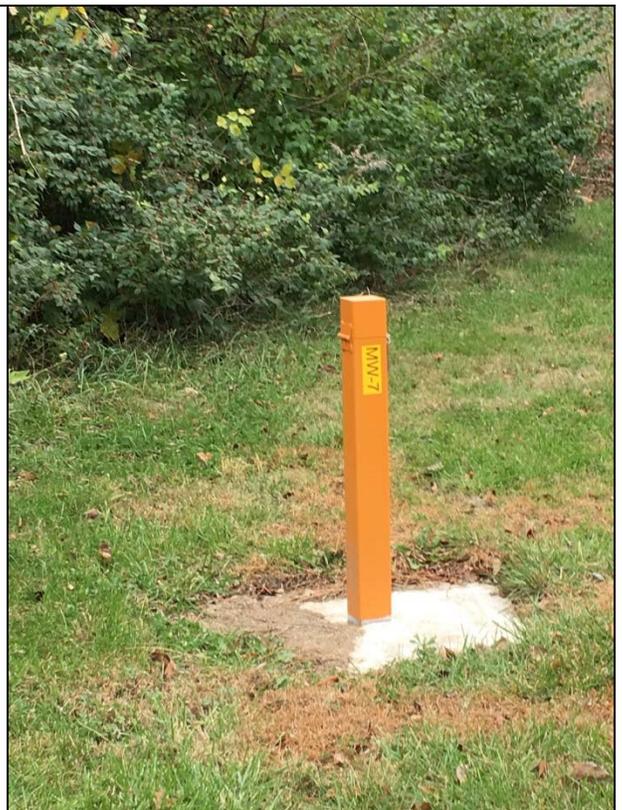
Photograph No. 24

Upgradient well MW-7.
