## Annual Inspection Report Tecumseh Energy Center Industrial Landfill #0322

Westar Energy

Tecumseh Energy Center

January 2017

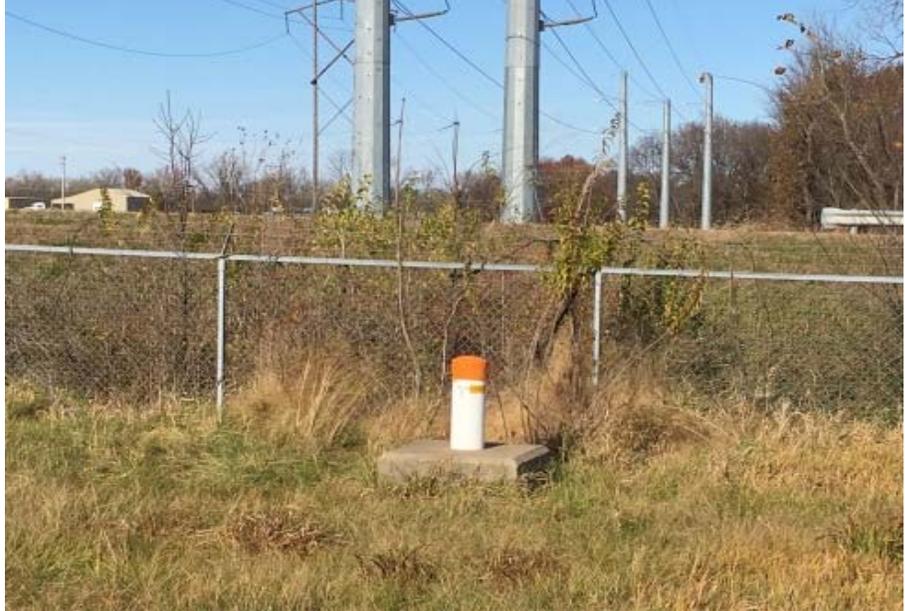
<p><b>Photograph No. 4</b></p> <p><b>Date:</b> November 28, 2016</p> <p><b>Direction:</b> North</p>

<p><b>Description:</b> Observing Monitoring Well-1 along the northern border.</p>

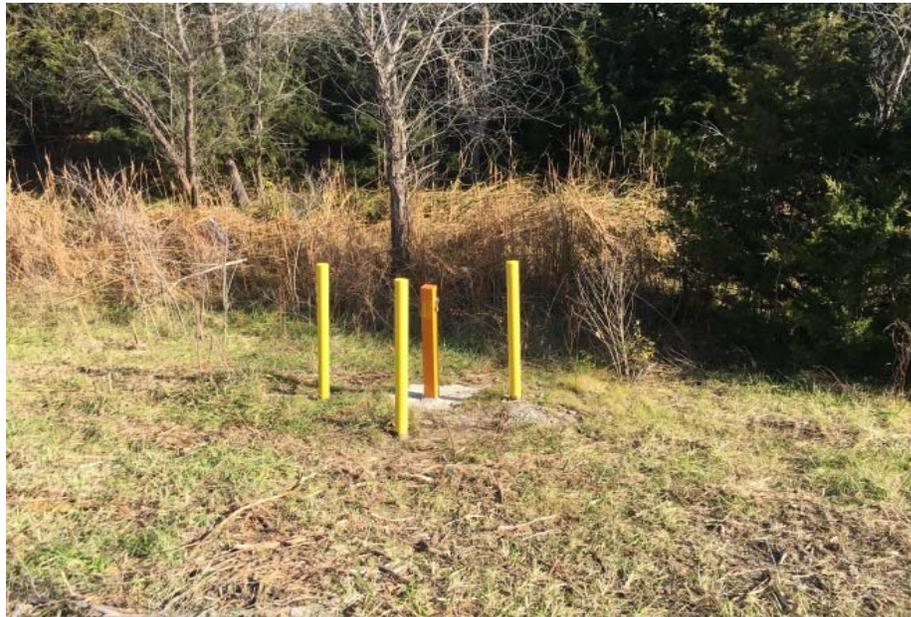
<p><b>Photograph No. 8</b></p> <p><b>Date:</b> November 28, 2016</p> <p><b>Direction:</b> East</p>

<p><b>Description:</b> Observing Monitoring Well-5 along eastern border.</p>

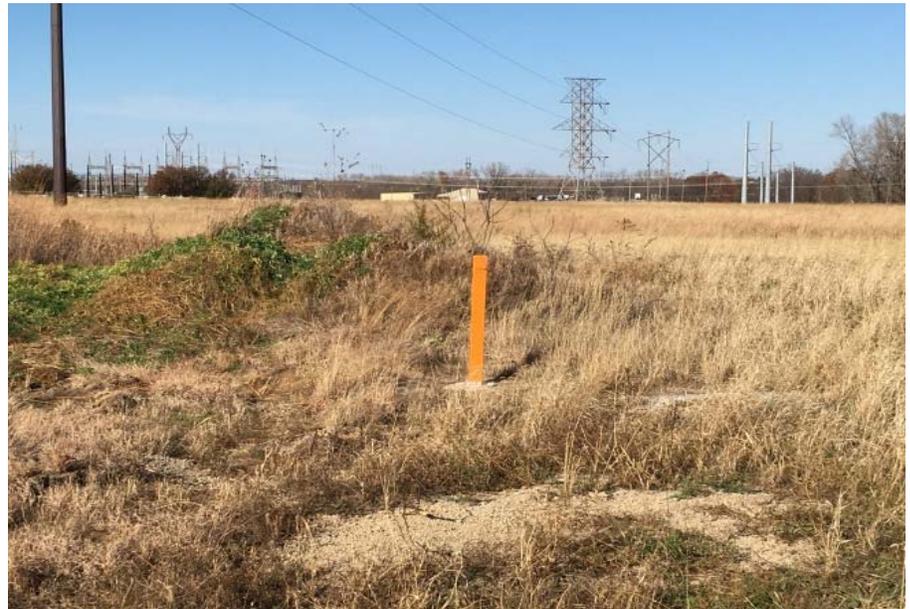
<p><b>Photograph No. 13</b></p> <p><b>Date:</b> November 28, 2016</p> <p><b>Direction:</b> Northwest</p>

<p><b>Description:</b> Observing Piezometer-1 used to gauge water levels in CCR unit as part of seep evaluation.</p>

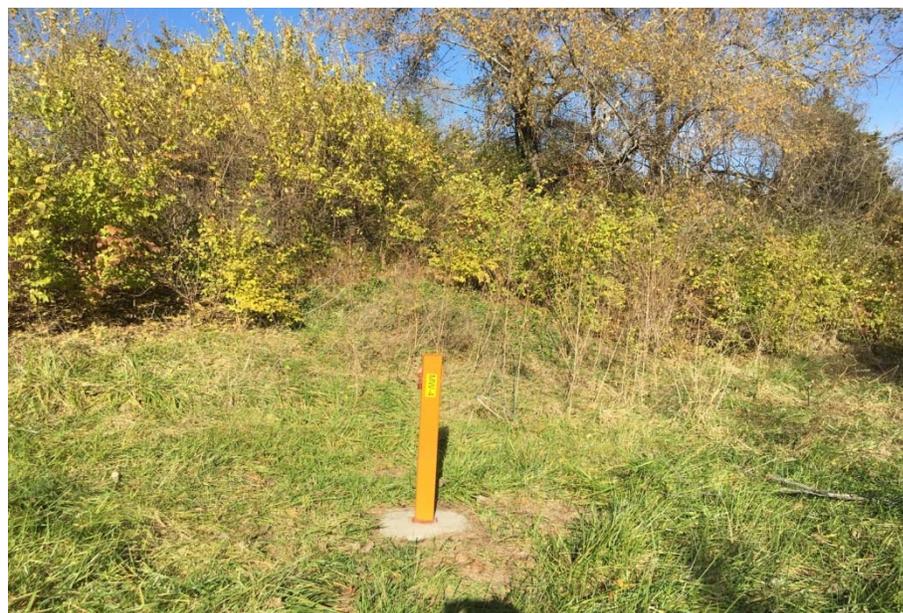
<p><b>Photograph No. 24</b></p> <p><b>Date:</b> November 28, 2016</p> <p><b>Direction:</b> East</p>

<p><b>Description:</b> Observing Monitoring Well-4 along southern border.</p>
