REPORT ON
PERIODIC STRUCTURAL STABILITY ASSESSMENT
BOTTOM ASH SETTLING AREA
JEFFREY ENERGY CENTER
ST. MARYS, KANSAS

by Haley & Aldrich, Inc.
Cleveland, Ohio

for Evergy Kansas Central, Inc.
St. Marys, Kansas

File No. 129778-047
October 2021

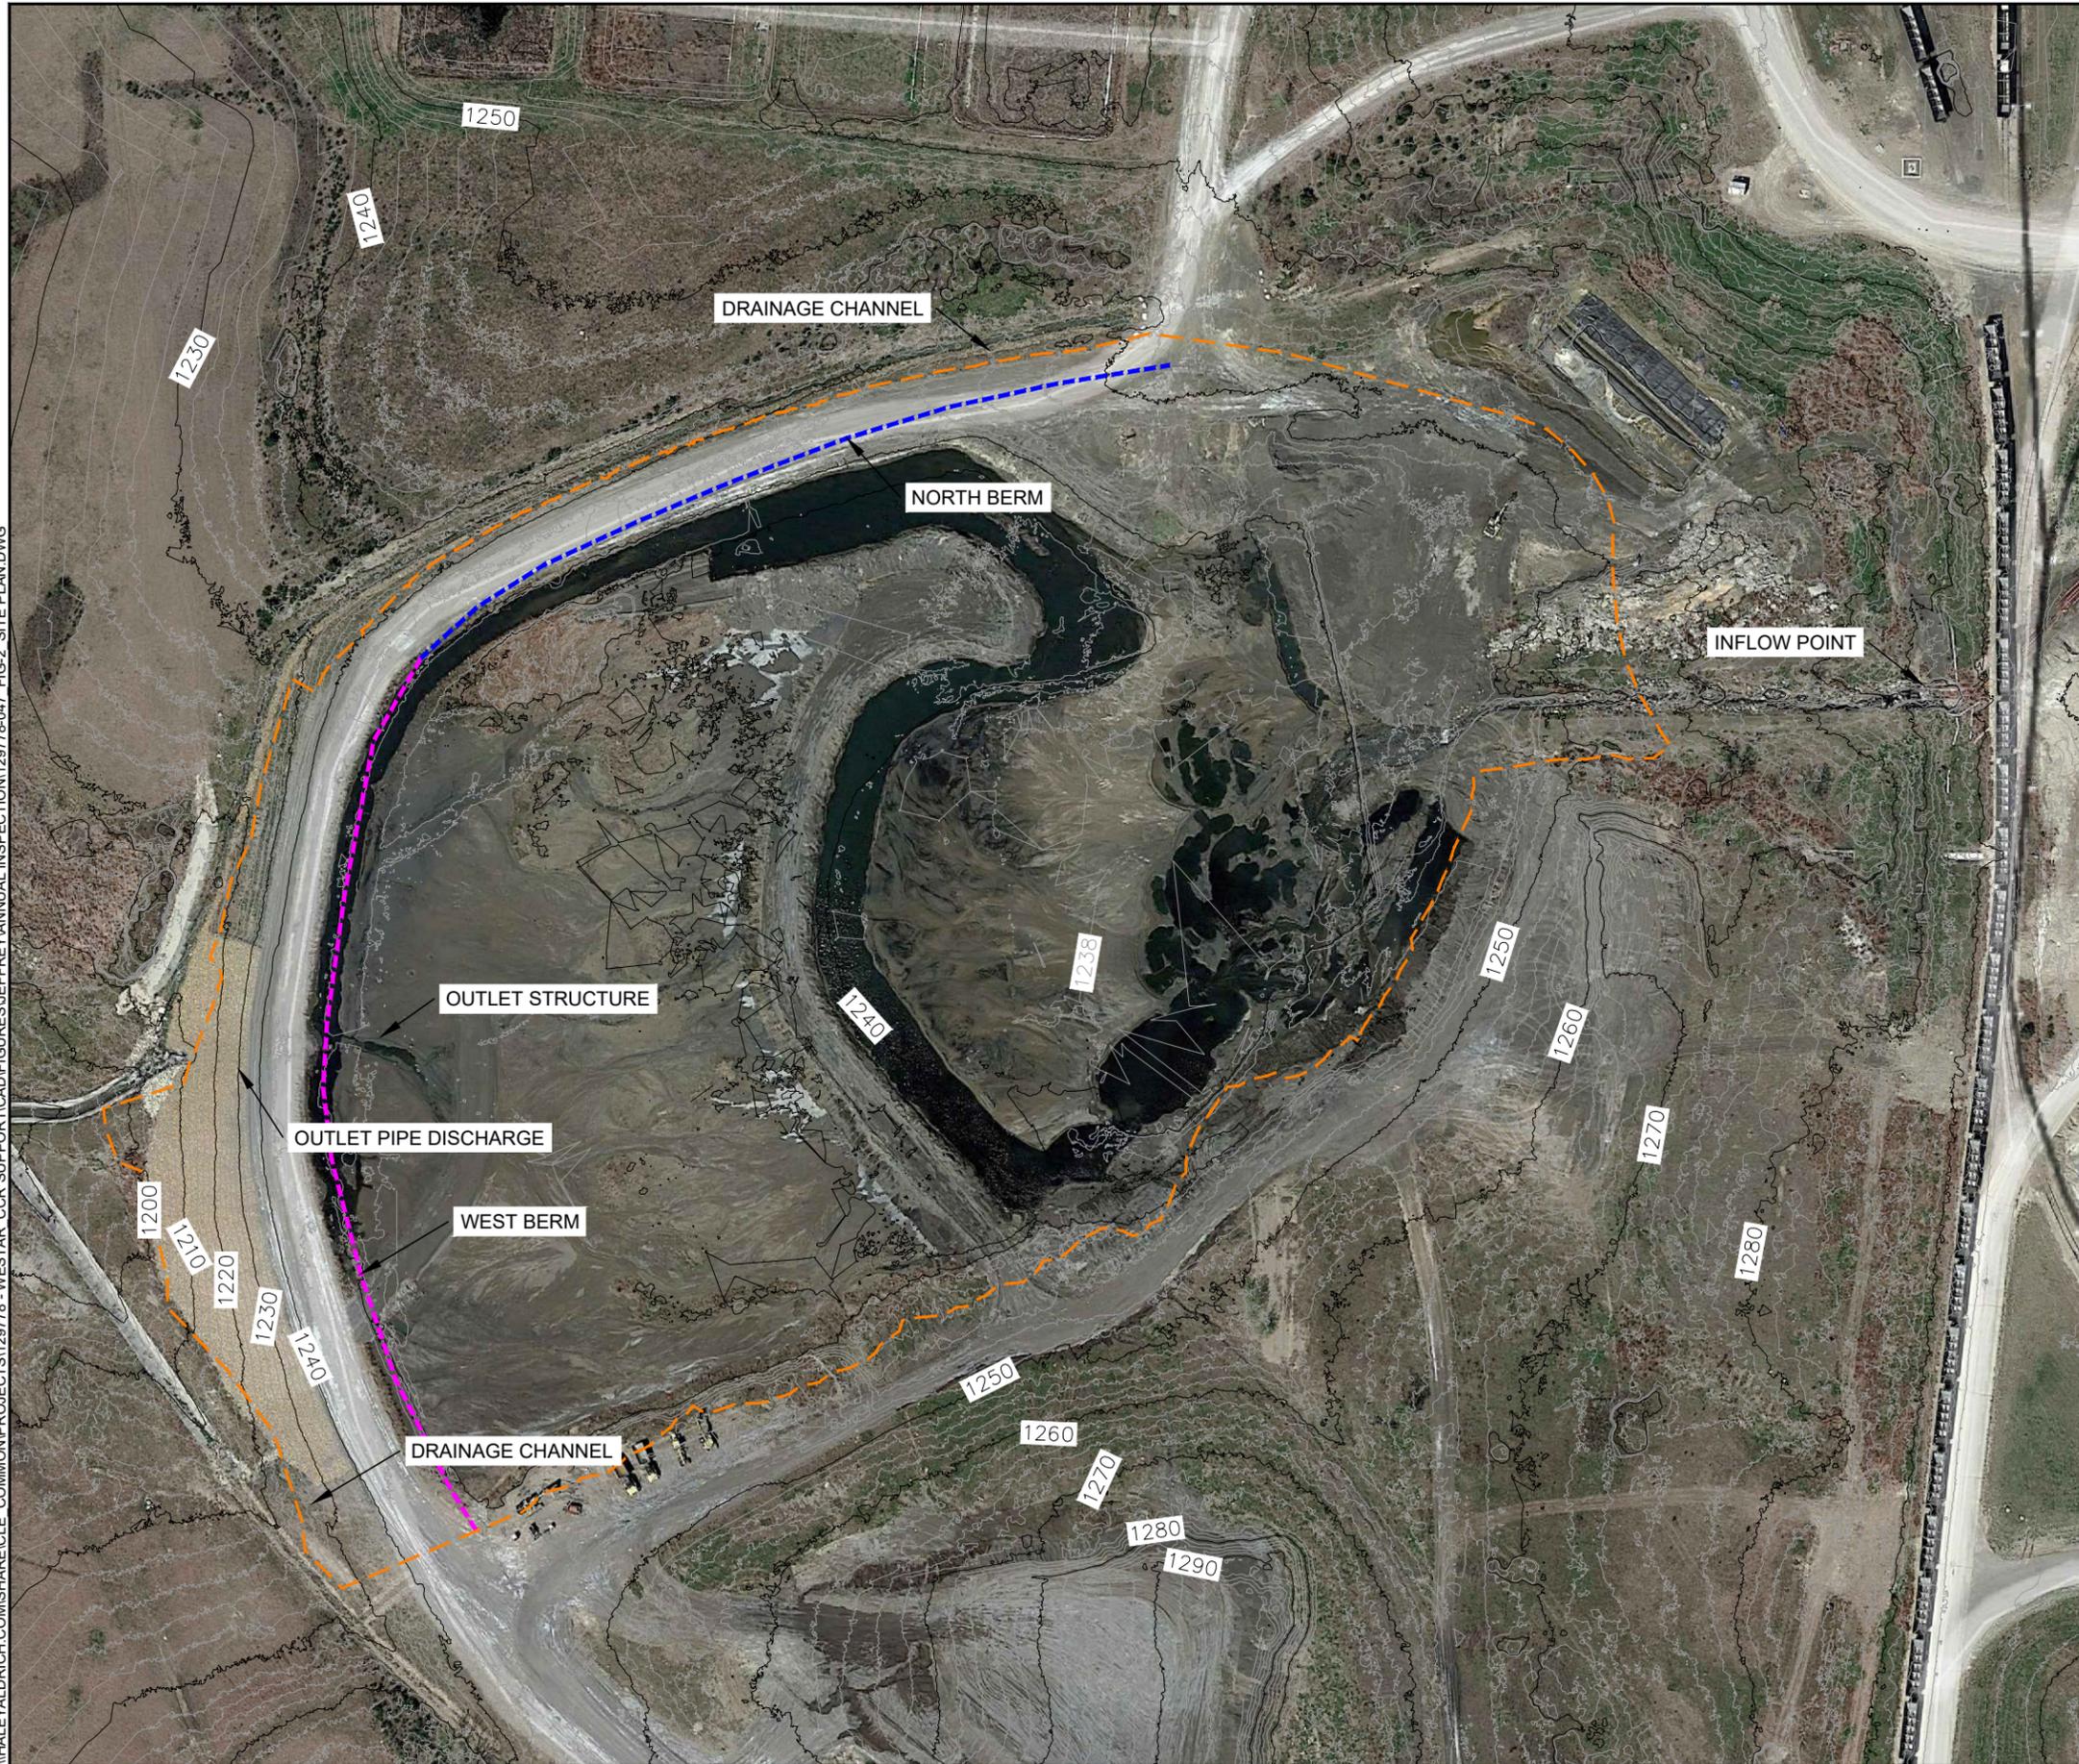
LUCAS, ANDY
\\HALEYALDRICH.COM\SHARE\COMMON\PROJECTS\129778 - WESTAR_CCR_SUPPORT\CAD\FIGURES\JEFFREY\ANNUAL INSPECTION\129778-047 FIG-2 SITE PLAN.DWG
Printed: 9/23/2021 7:58 AM Layout: SITE PLAN

Embankments (referred to herein as berms) exist along the west and north sides of the impoundment. For the purposes of this report, these berms are hereinafter referred to as the “west berm” and the “north berm.” The limits of the west and north berms are shown on Figure 2. Small earthen berms have been added on the east side of the BASA to direct surface water around the unit.
